ADVANCE WORKS CONTRACT

NFMHS, PORTRANE, CO. DUBLIN

The Temporary Asylum

LICENCE REF: 15E0396

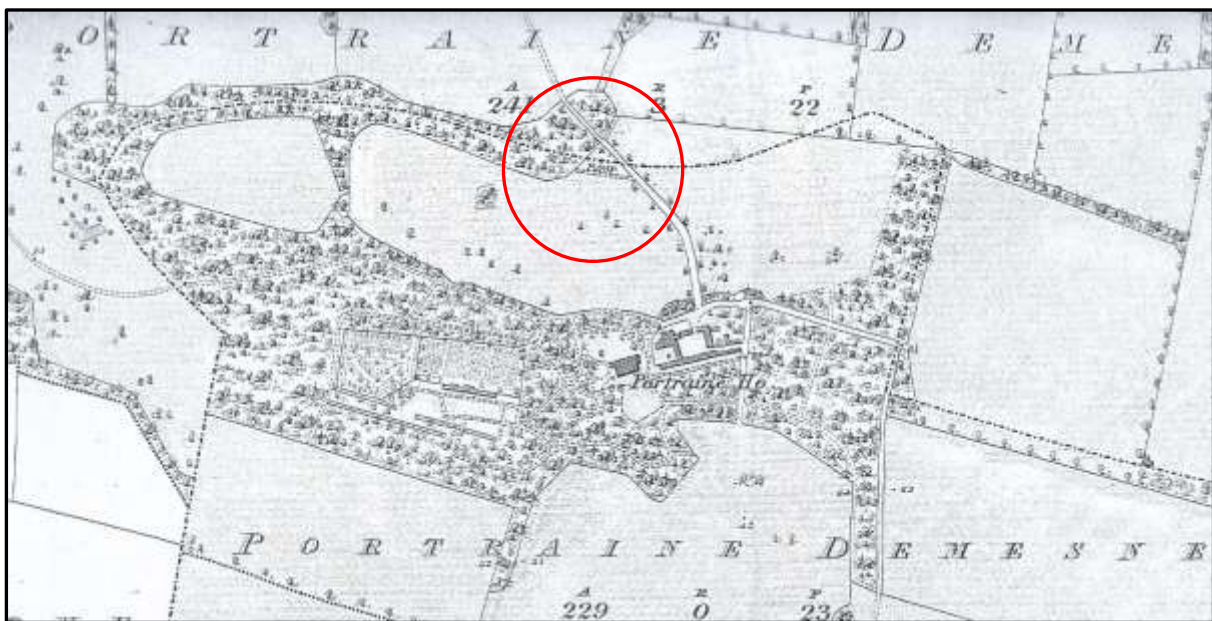
Location of horse whim operated water pump.

The pump mechanism is placed over a brick lined well. The surface opening of the well is raised above the natural ground surface and encased in an earthwork mound, designed to allow the boom extending from the whim to operate at a level that is comfortable for the horse. The mound, in this case is circular defining a walking track for the animal.

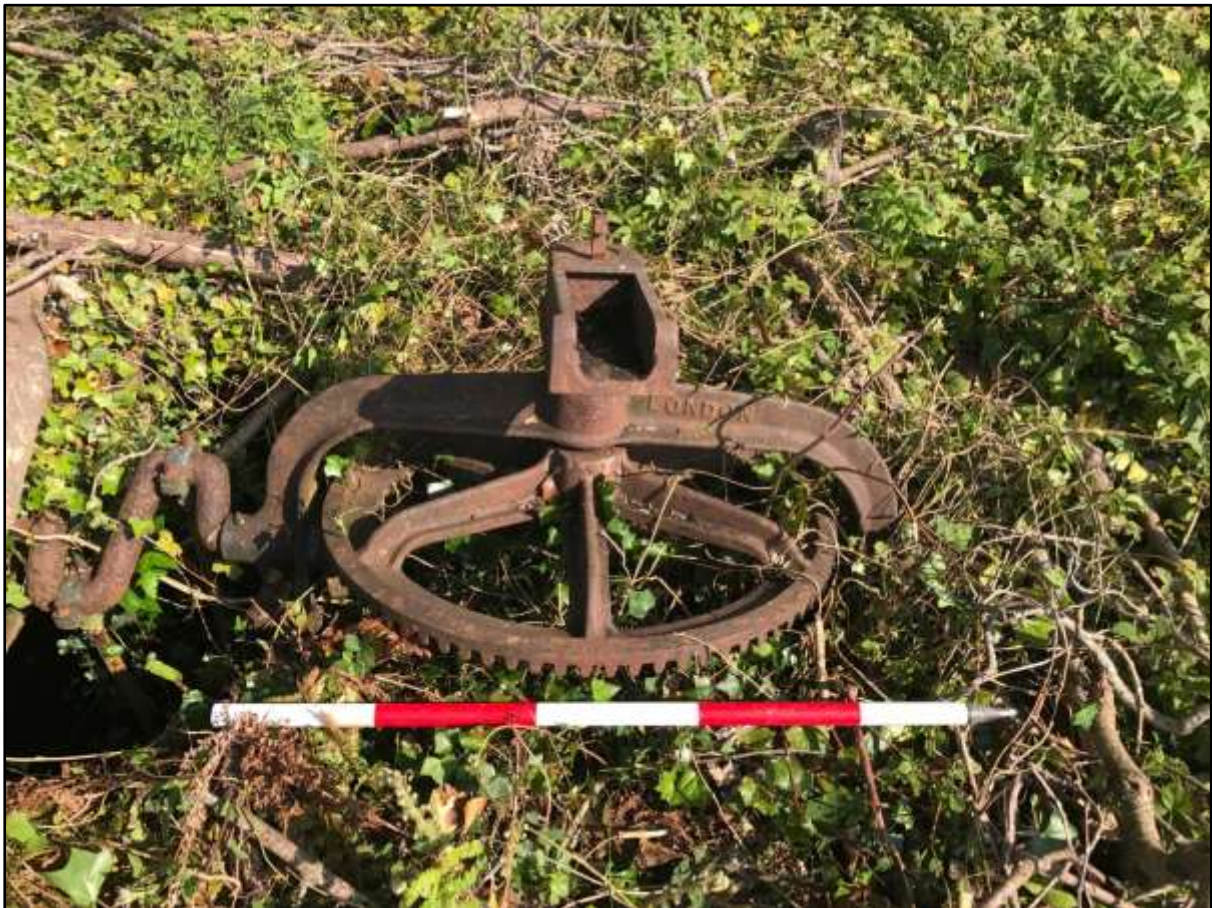
Warner Pump mechanism.

It is likely that the Warner horse wheel pump at Portrane dates to the 1850s and was installed to furnish a water supply to the new farm buildings to the east.

Presently the pump mechanism is in good condition but is vulnerable to theft or vandalism. As a minimum requirement the pump should be surveyed and fully recorded. Its long term security should be considered by both the HSE Estates and Fingal County Council.

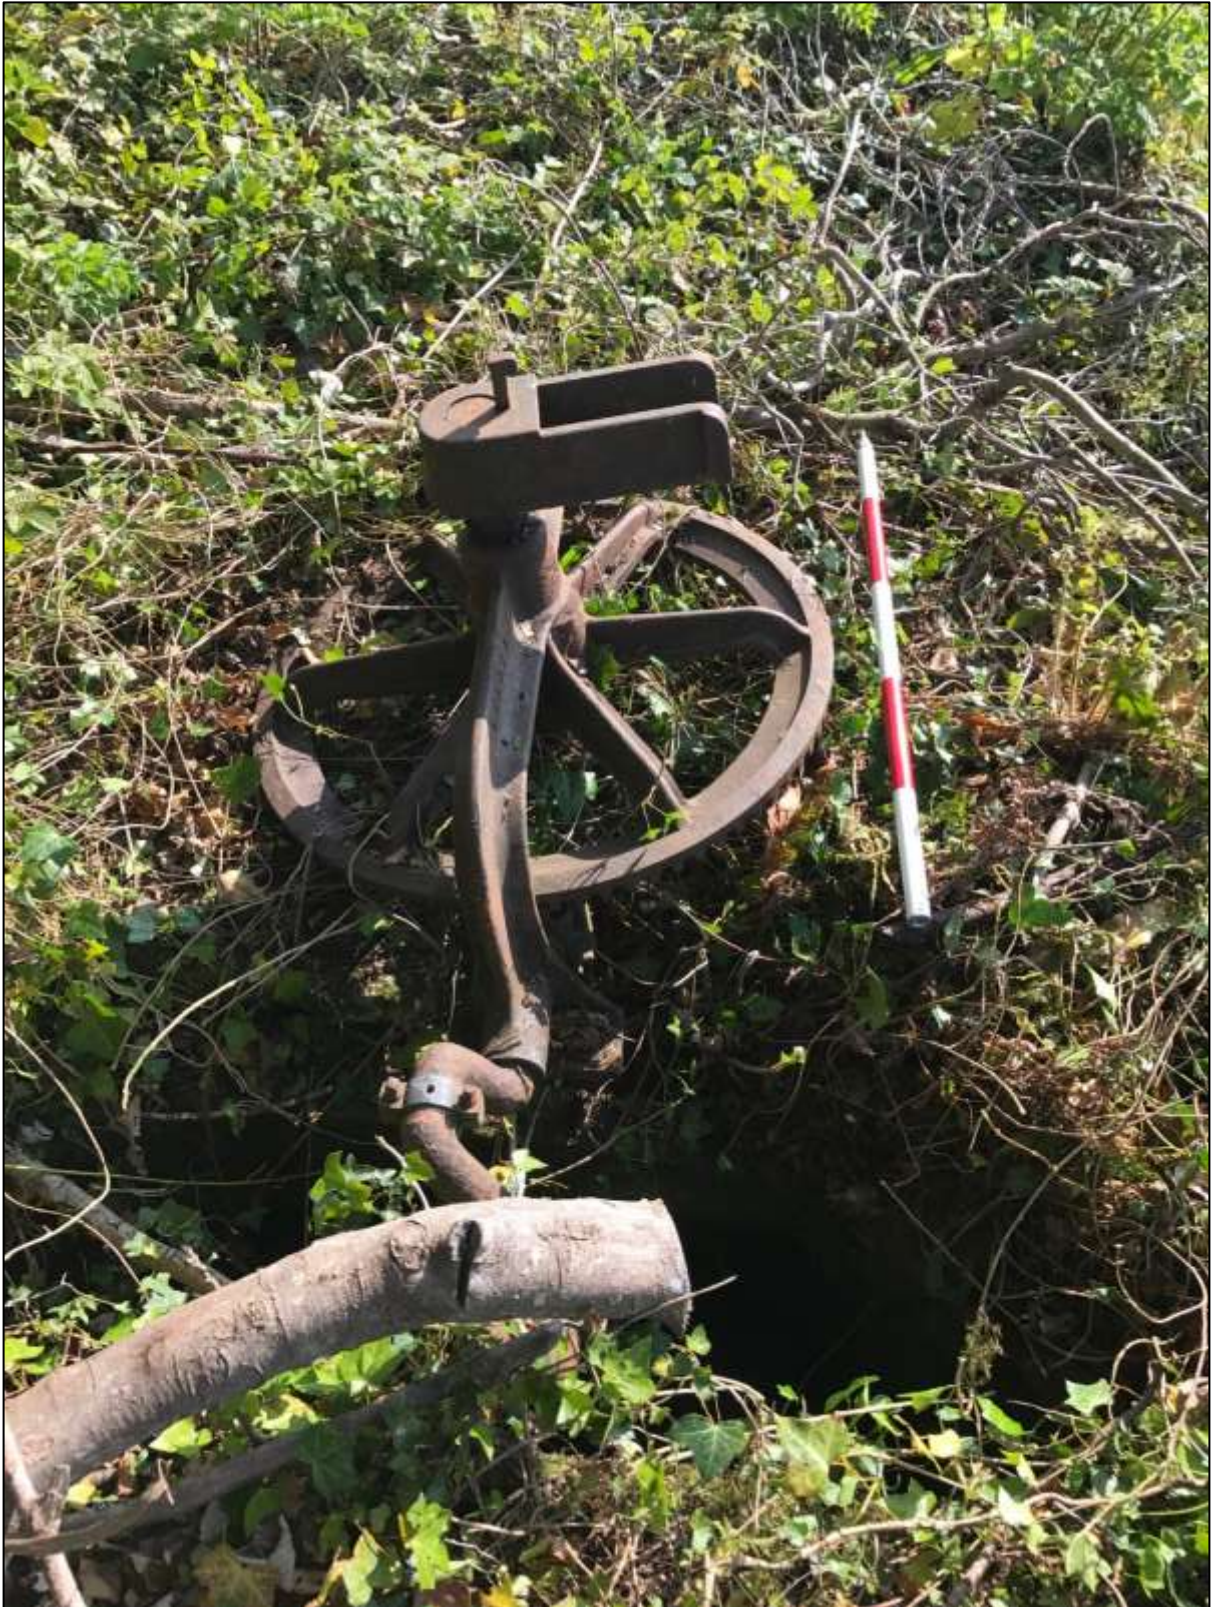
Warner Pump mechanism

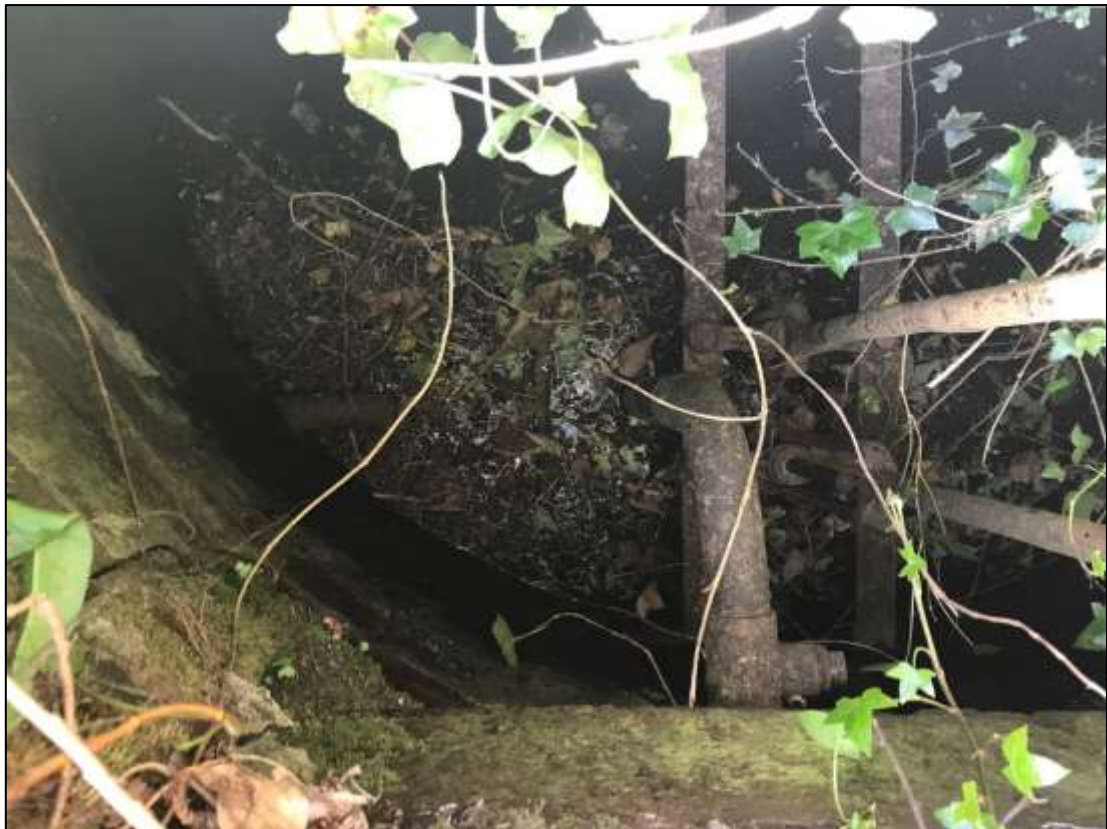
Warner Pump mechanism

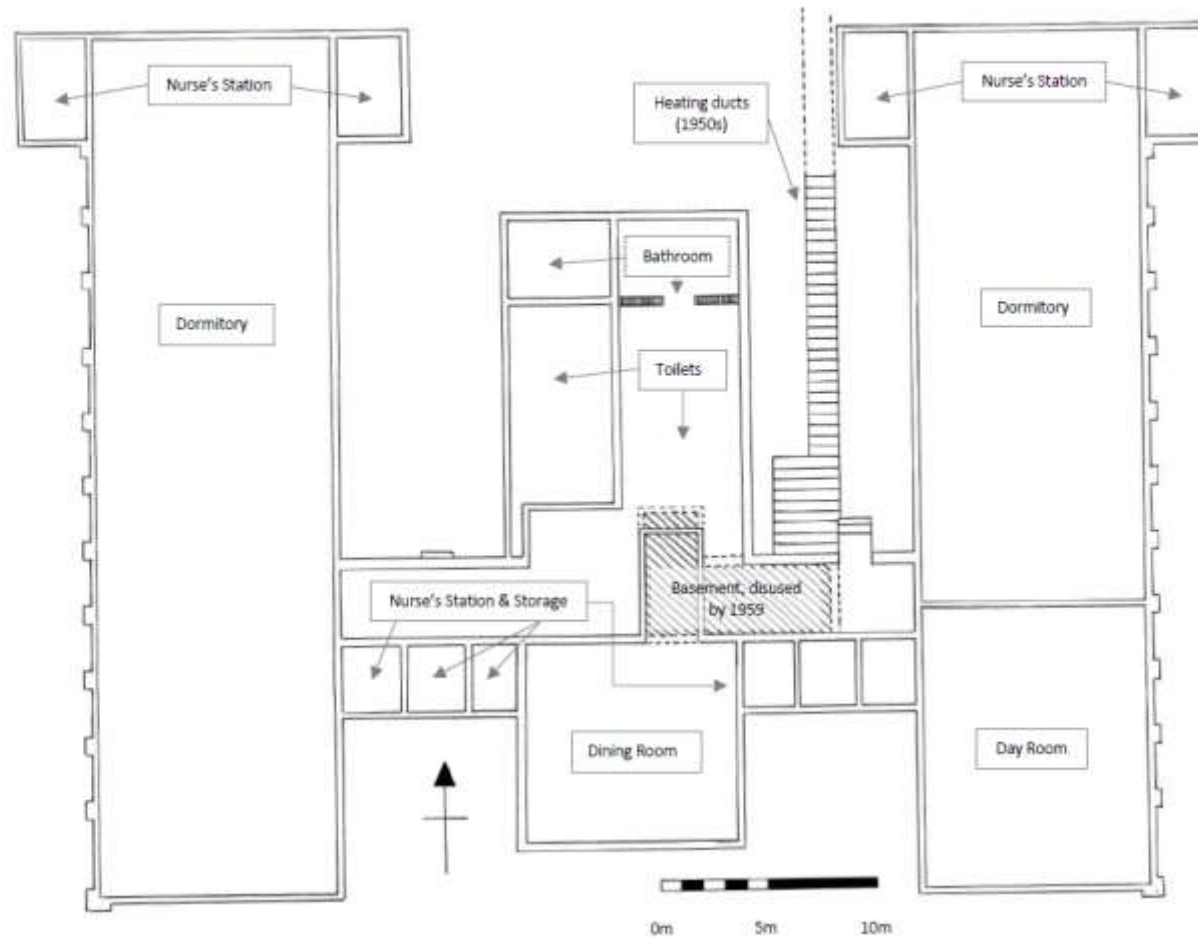
The Temporary Asylum - Ashlin's Block No 4. Corresponds to St Ita's Block 9 (Male). The plan shows the foundation lines and ancillary services as excavated in 2016. Identification of rooms taken from service plans from the Engineer's Department, St Ita's Hospital, Portrane.

Fig 13. Area 2. Plan of Ashlin's building No 4 / Block 9 as excavated (2016)

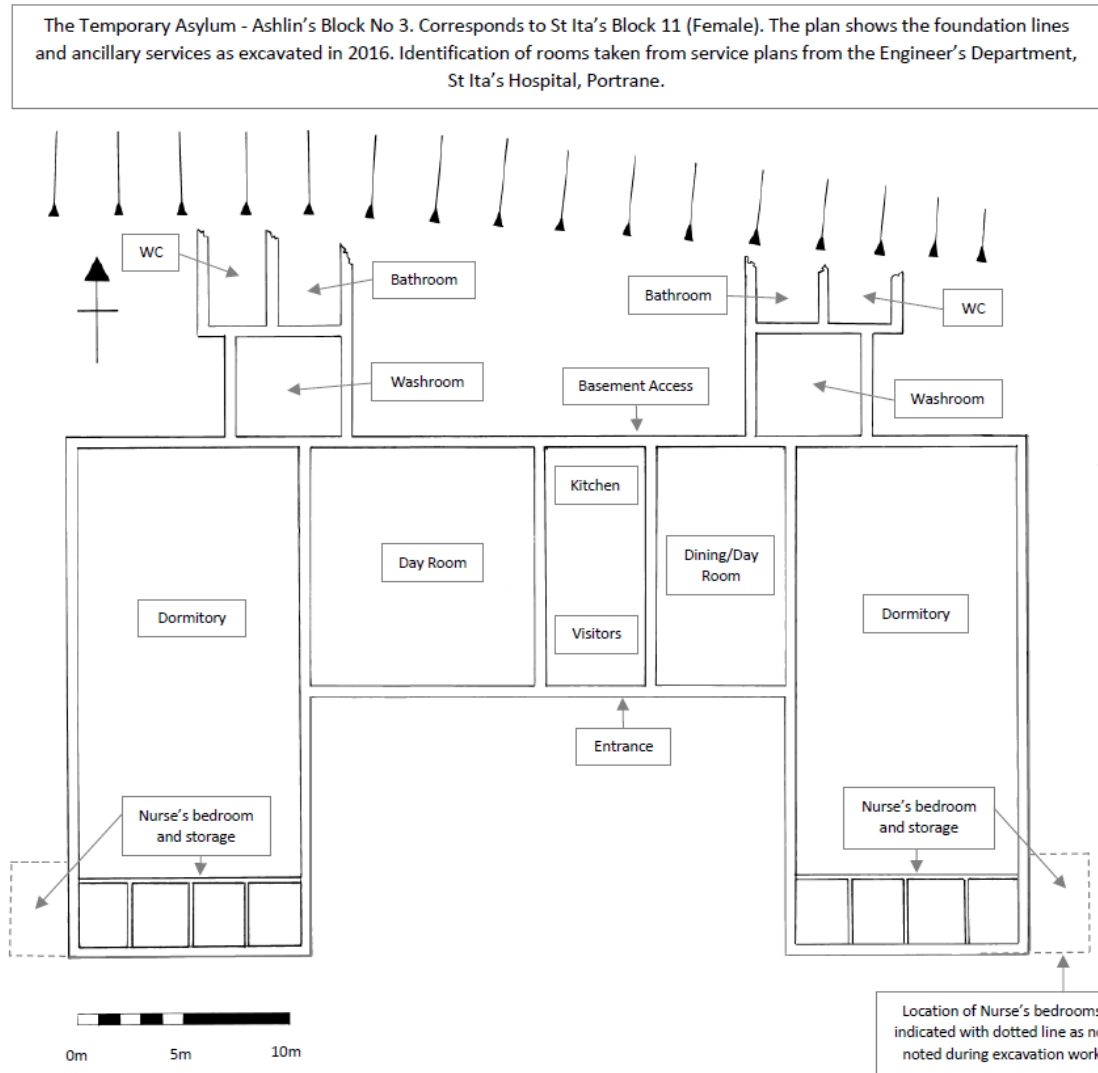
Fig 14. Area 2. Plan of Ashlin's building No 3 / Block 11 as excavated (2016)

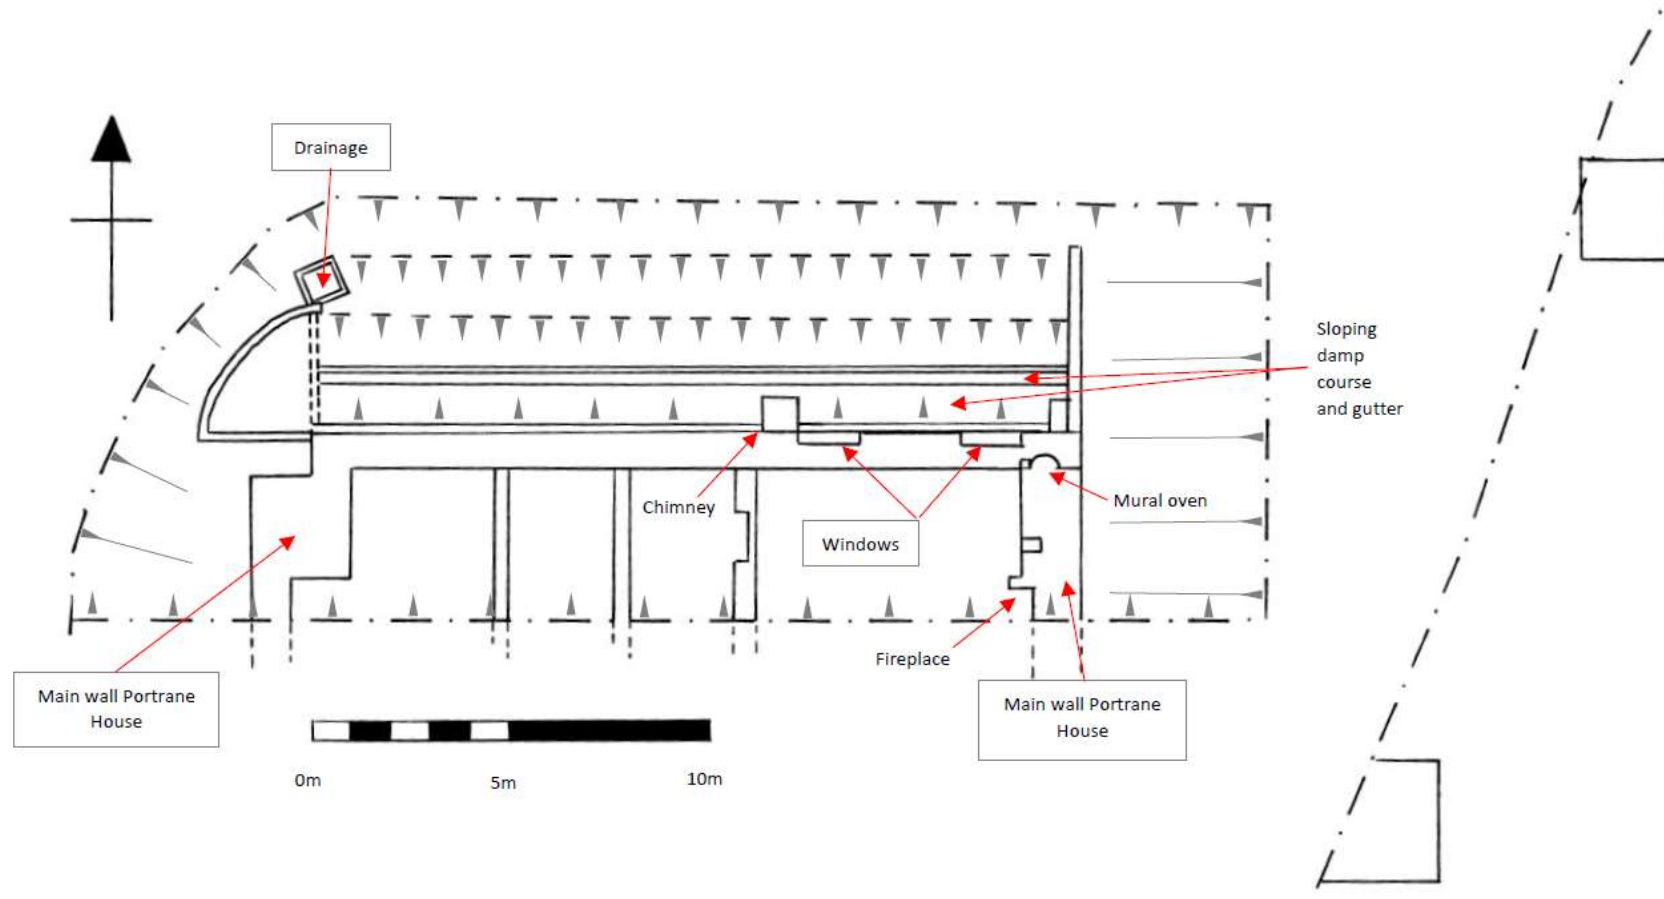
The Temporary Asylum – Portrane House (Mount Evans).
The plan shows the basement level, ancillary services and structural alterations as excavated in 2016.

Fig 15. Area 3. Portrane House, basement level as excavated (2016)

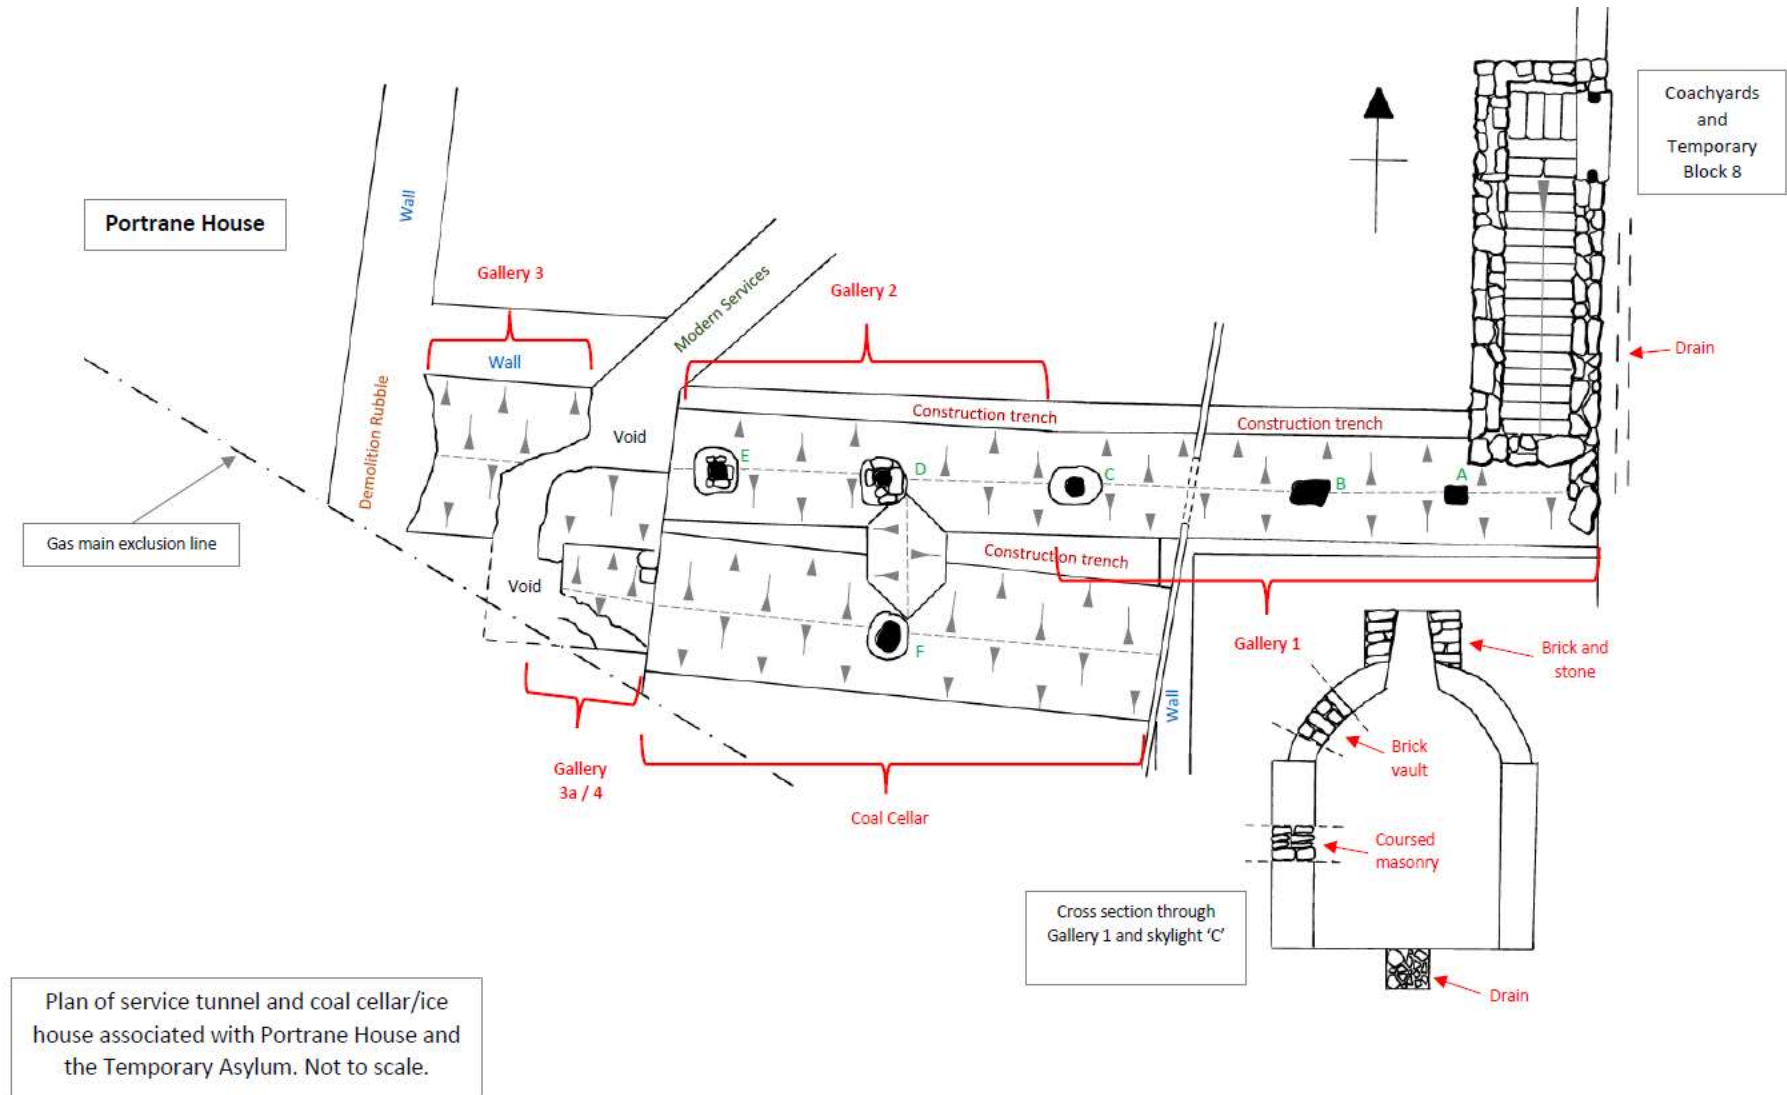
Fig 16. Area 3. Service tunnels to the east of Portrane House as excavated (2016)

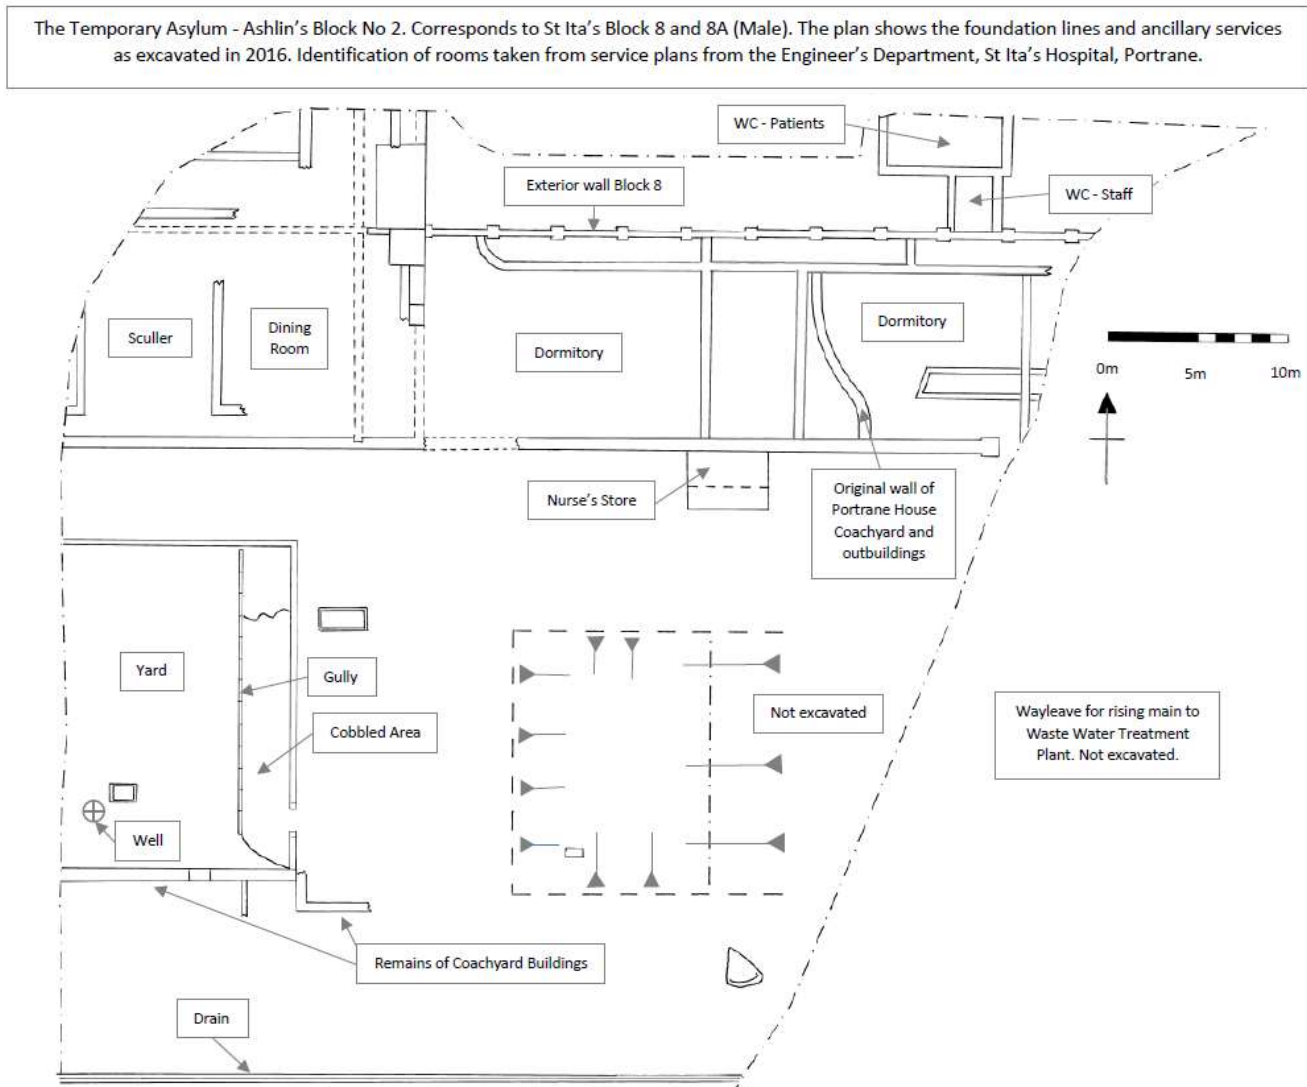
Fig 17. Area 1. Ashlin's building No 2 / Block 8/8a and the Portrane House yards as excavated (2016)

The Temporary Asylum - Ashlin's Block No 2. Corresponds to St Ita's Block 8 and 8A (Male). The plan shows the foundation lines and ancillary services as excavated in 2016. Identification of rooms taken from service plans from the Engineer's Department, St Ita's Hospital, Portrane.

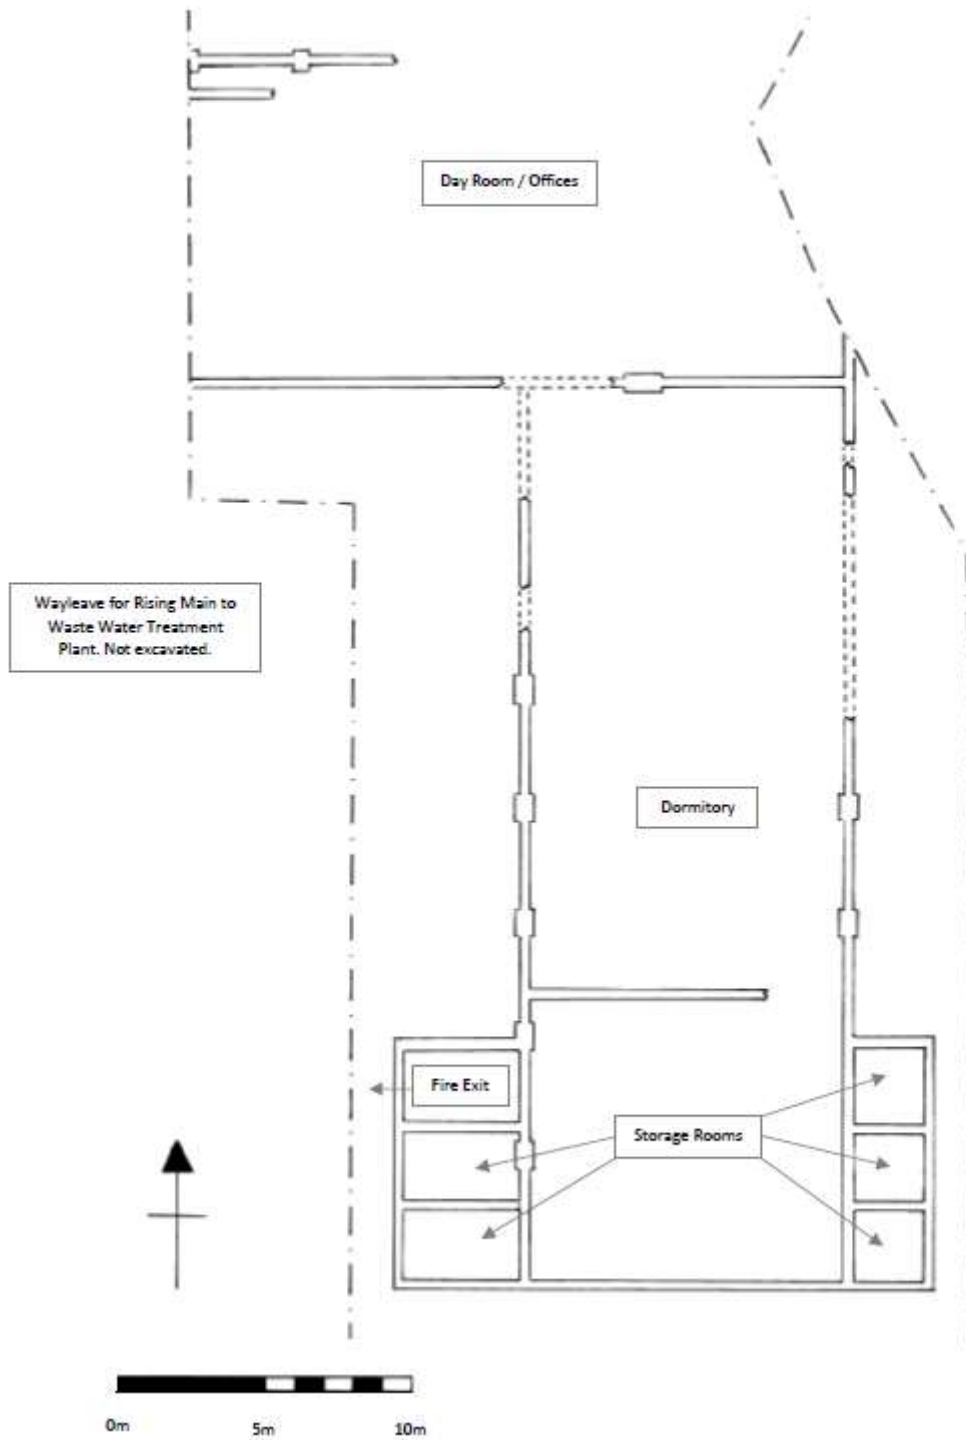
Fig 18. Area 1. Ashlin's building No 2 / Block 8/8a, Dormitory block on east side as excavated (2016)

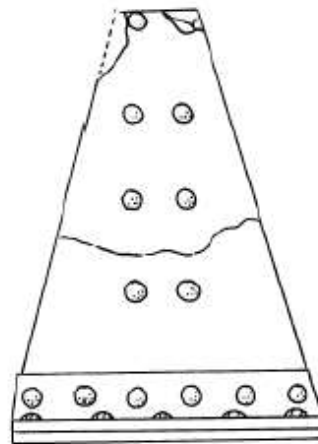
Cast iron and riveted stanchion footing recovered from the concrete foundations of Ashlin's Block 4 (Block 9). Scale 1:5

Fig 19. Area 2. Cast iron and rivetted footing to RSJ framework of Ashlin's building No 4 / Block 9

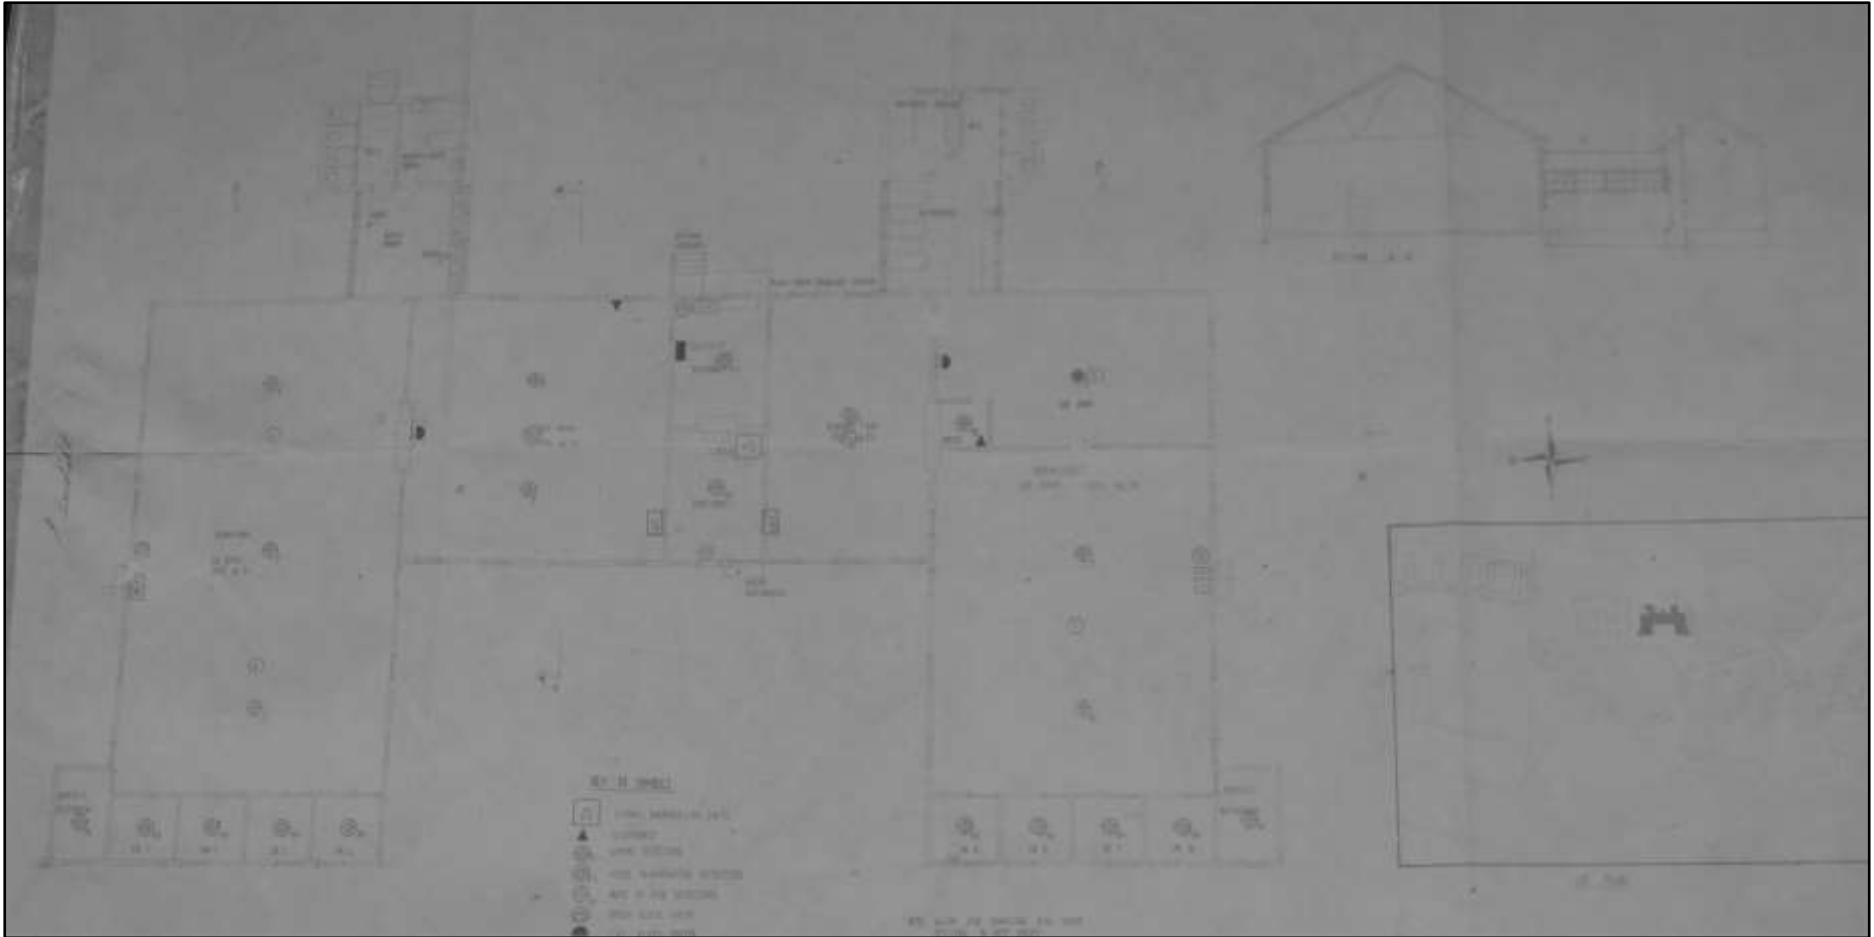
Fig 20. Ashlin's building No 3 / Block 11 – service drawing (1950s – Engineer's Department, St Ita's Hospital)

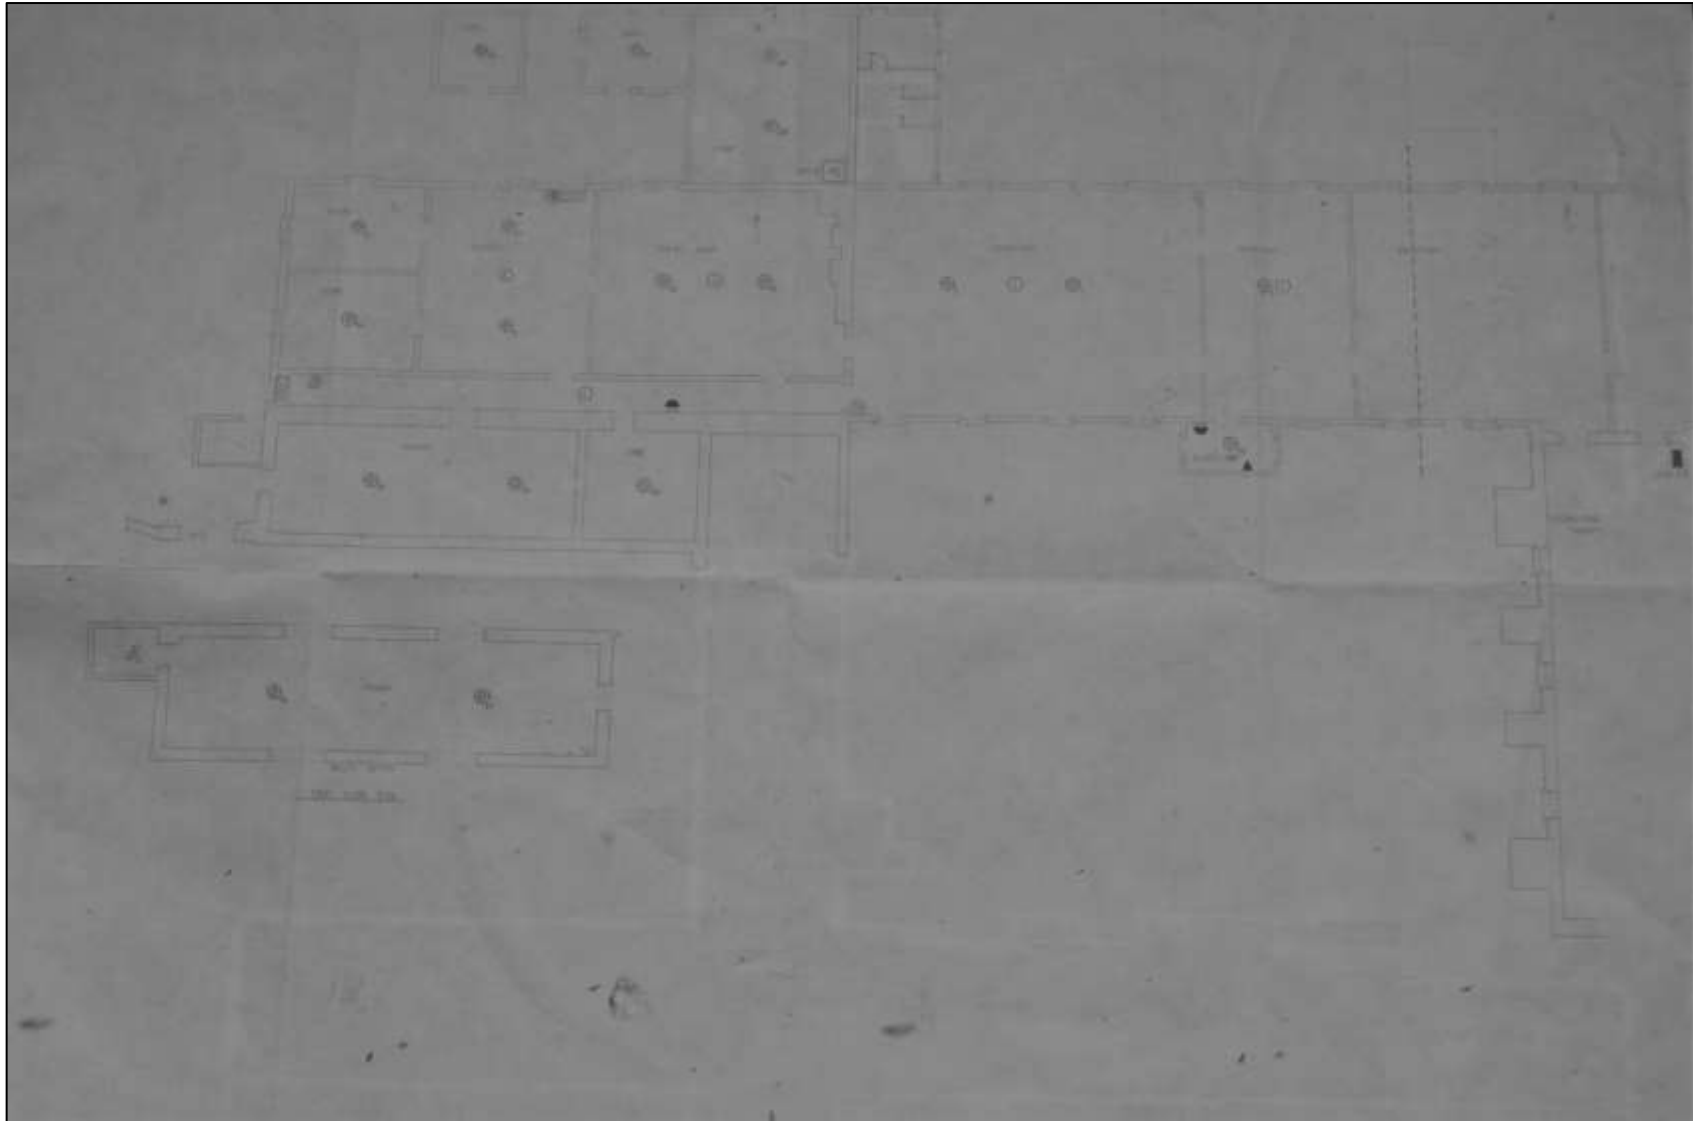
Fig 21. Ashlin's building No 2 / Block 8/8a (W) – service drawing (1950s – Engineer's Department, St Ita's Hospital)

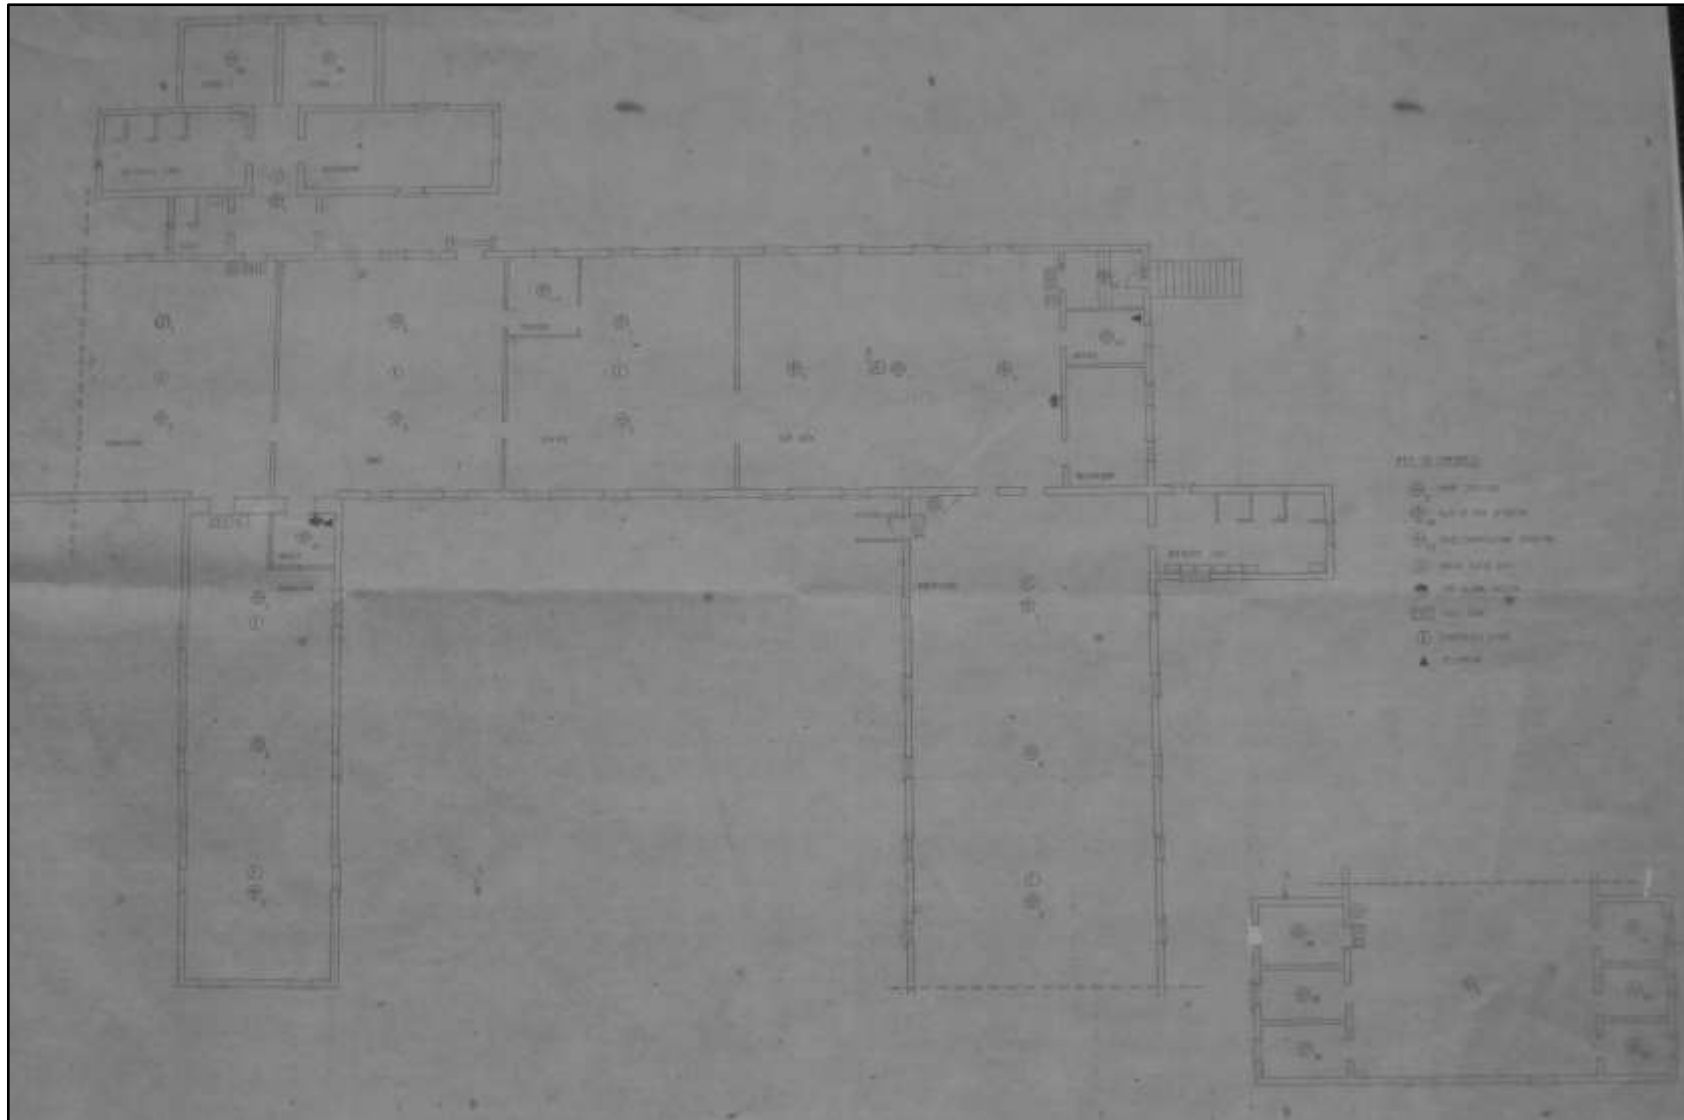
Fig 22. Ashlin's building No 2 / Block 8/8a (E) – service drawing (1950s – Engineer's Department, St. Ita's Hospital)

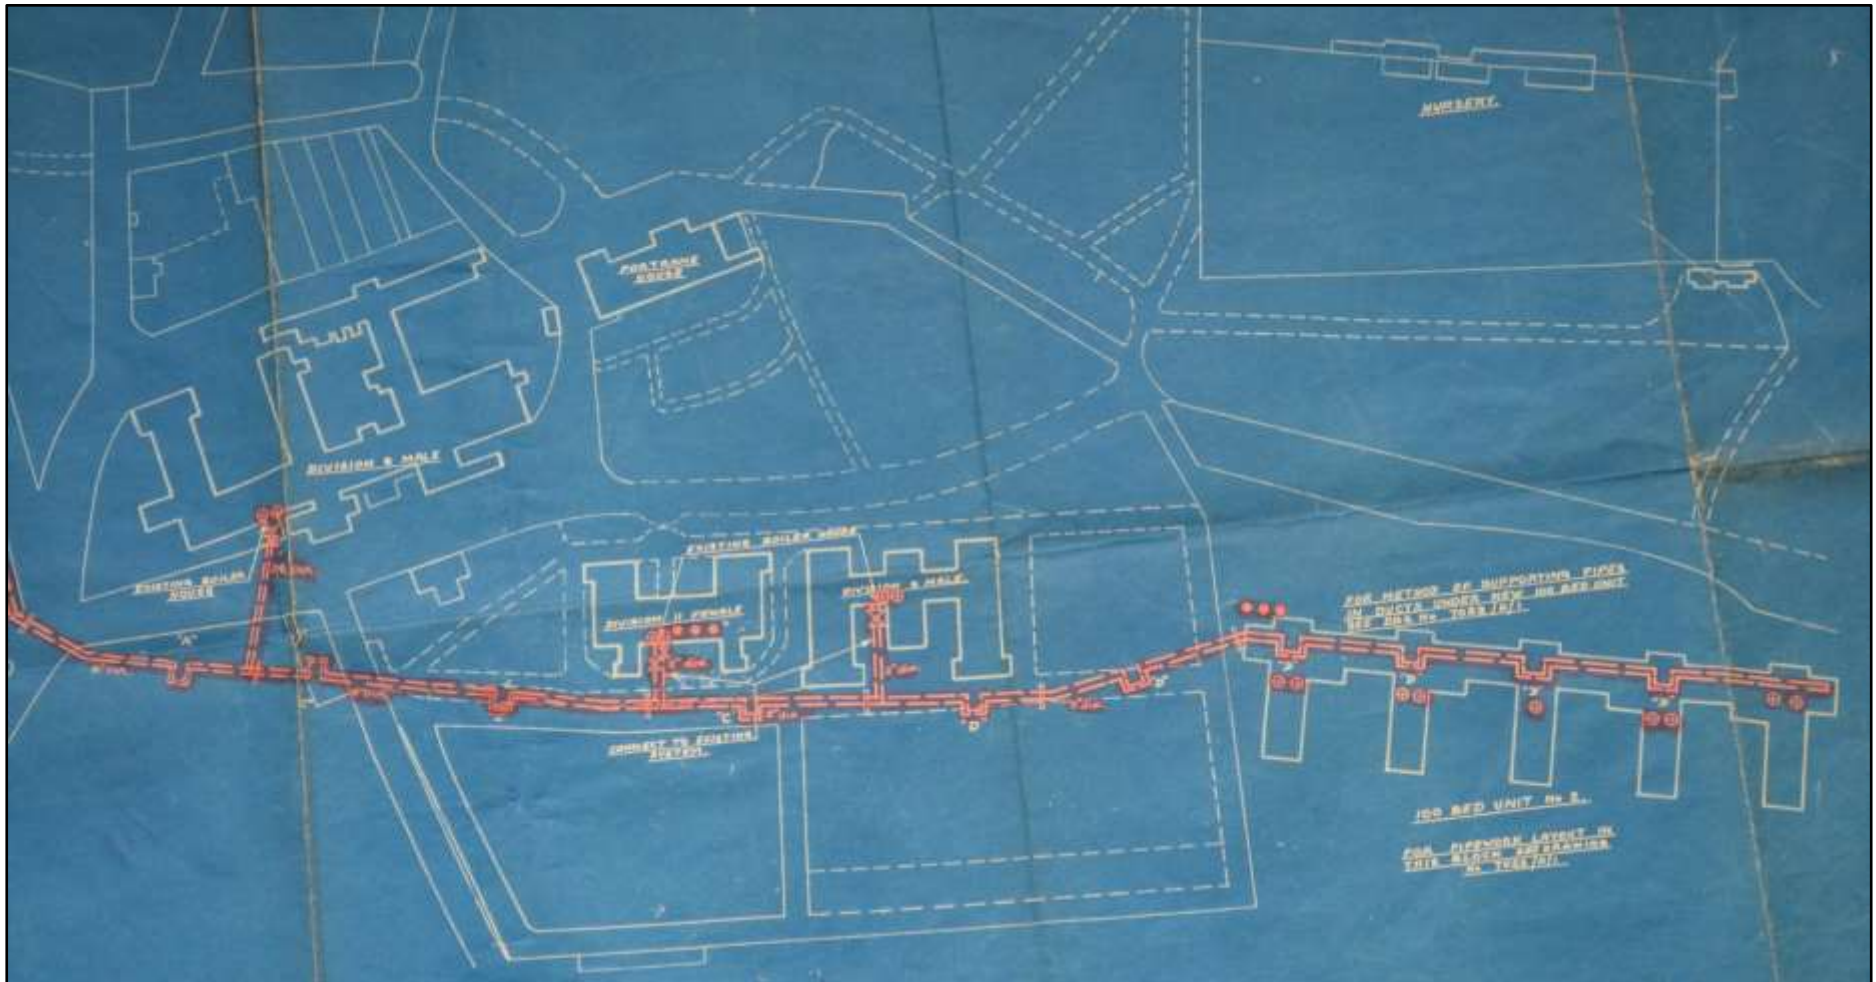
Fig 24. Heating blueprint showing connections to outlying buildings including the 'Temporaries'.

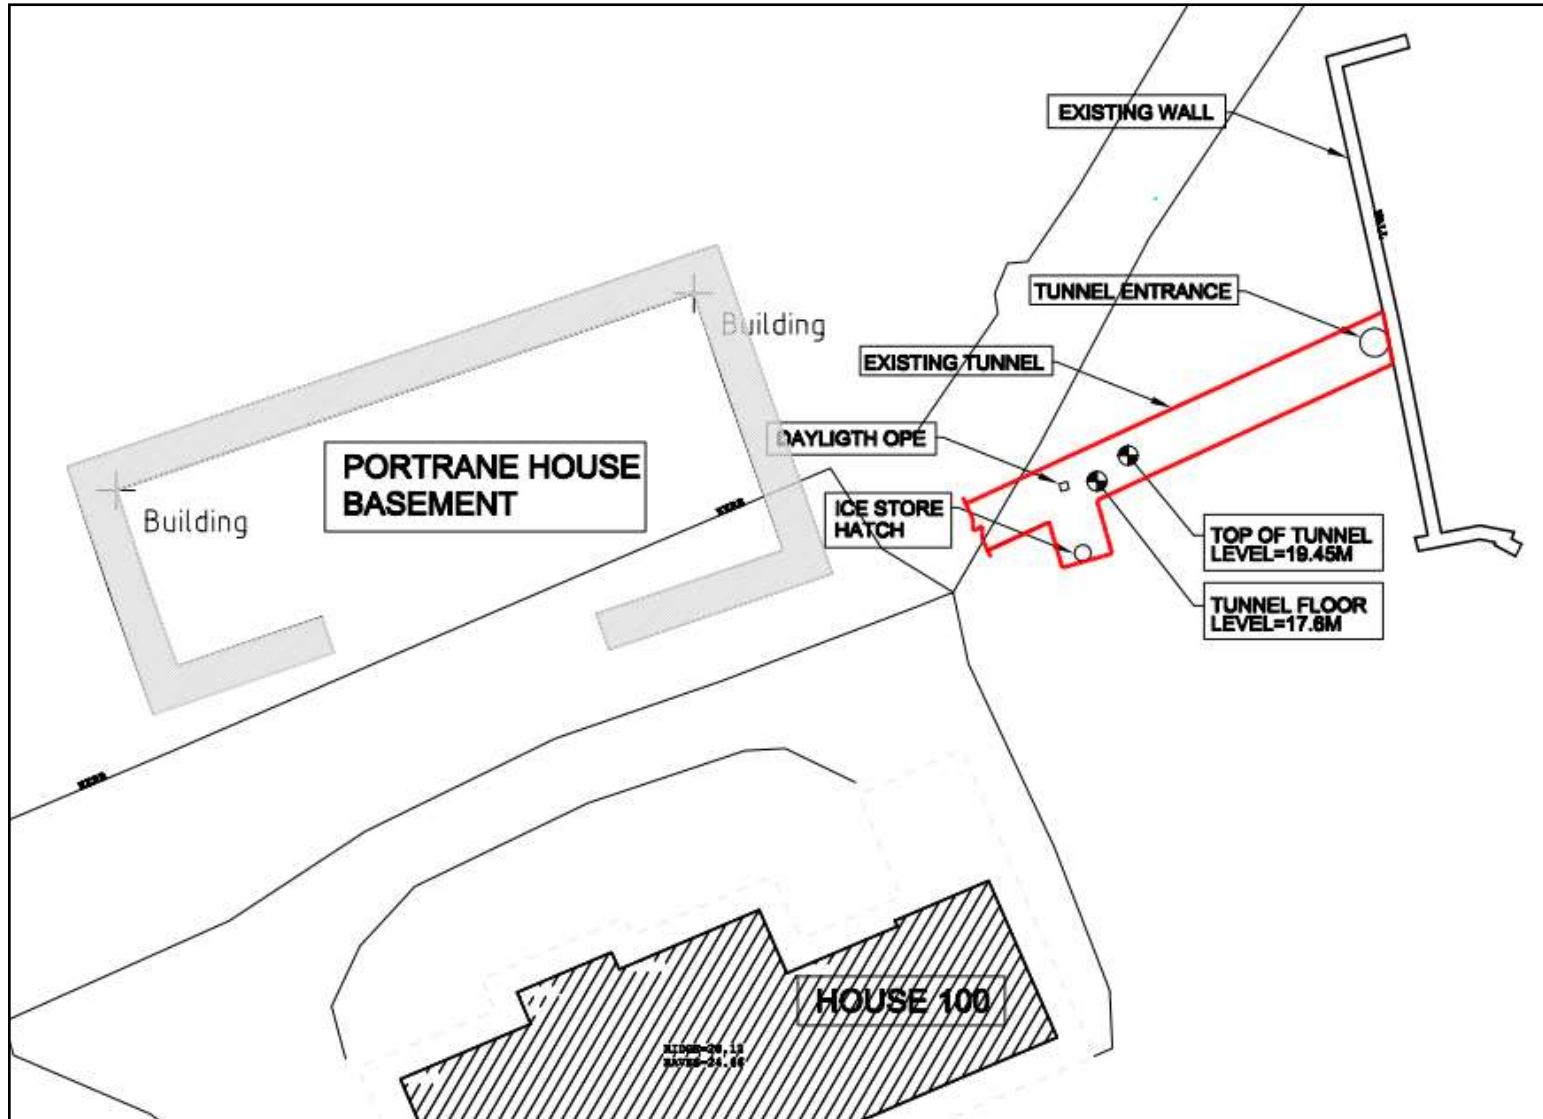
Fig 25. Survey data (Barnmore Demolition Ltd) showing location of basement and service tunnels as excavated
