ADVANCE WORKS CONTRACT

NFMHS, PORTRANE, CO. DUBLIN

The Temporary Asylum

LICENCE REF: 15E0396

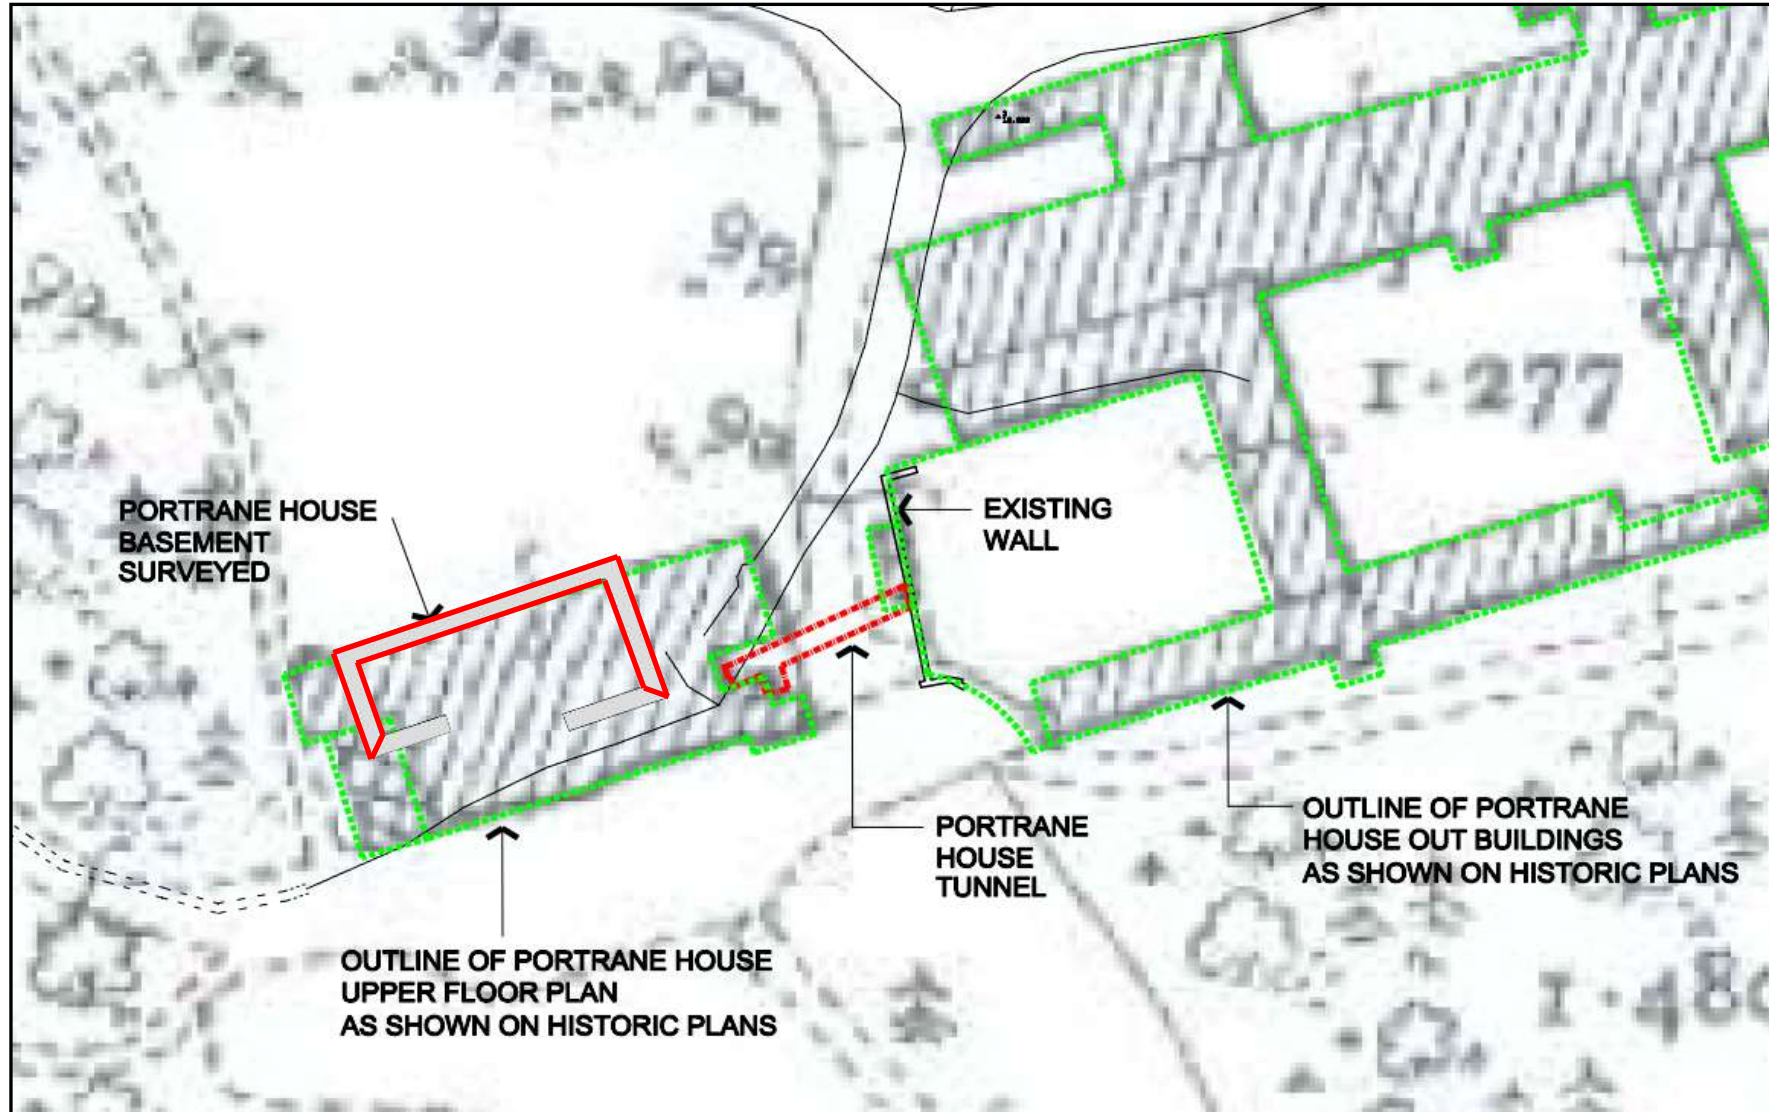
Fig 26. Survey data from excavation (Barnmore Demolition Ltd) overlaid on OS mapping.

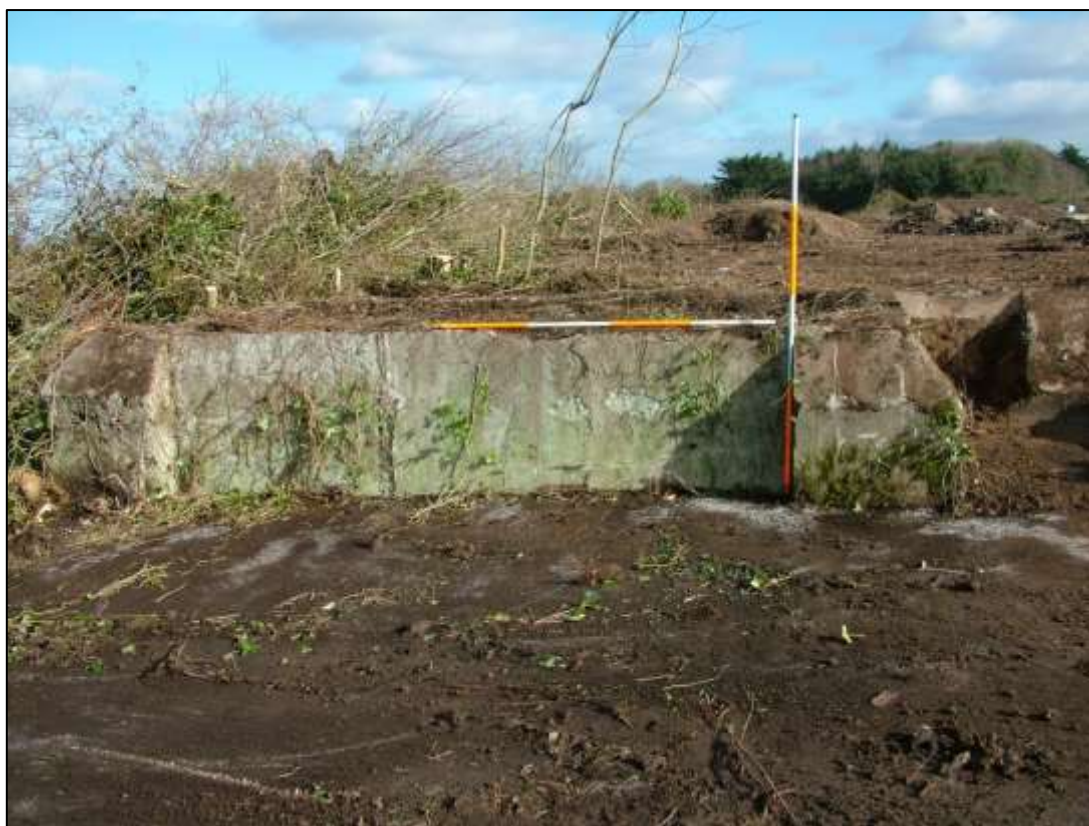
Plate 7. Area 2 – Extant foundation of Temporary No 4 / Block 9. NW corner looking E

Plate 7 NW corner, extant foundation plinth, looking E

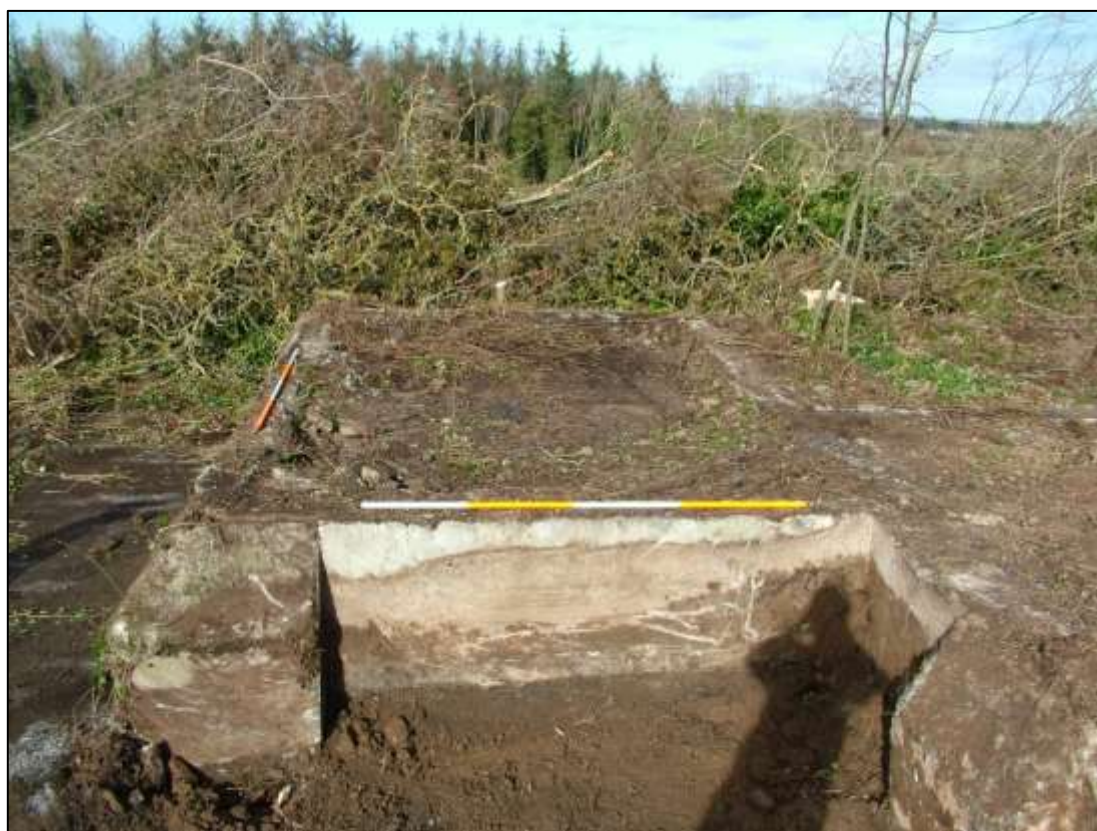
Plate 8. Area 2 – Extant foundation of Nurses Station/bedroom NW corner Block 9

Plate 8 NW corner, foundation of Nurse’s station / bedroom, looking N

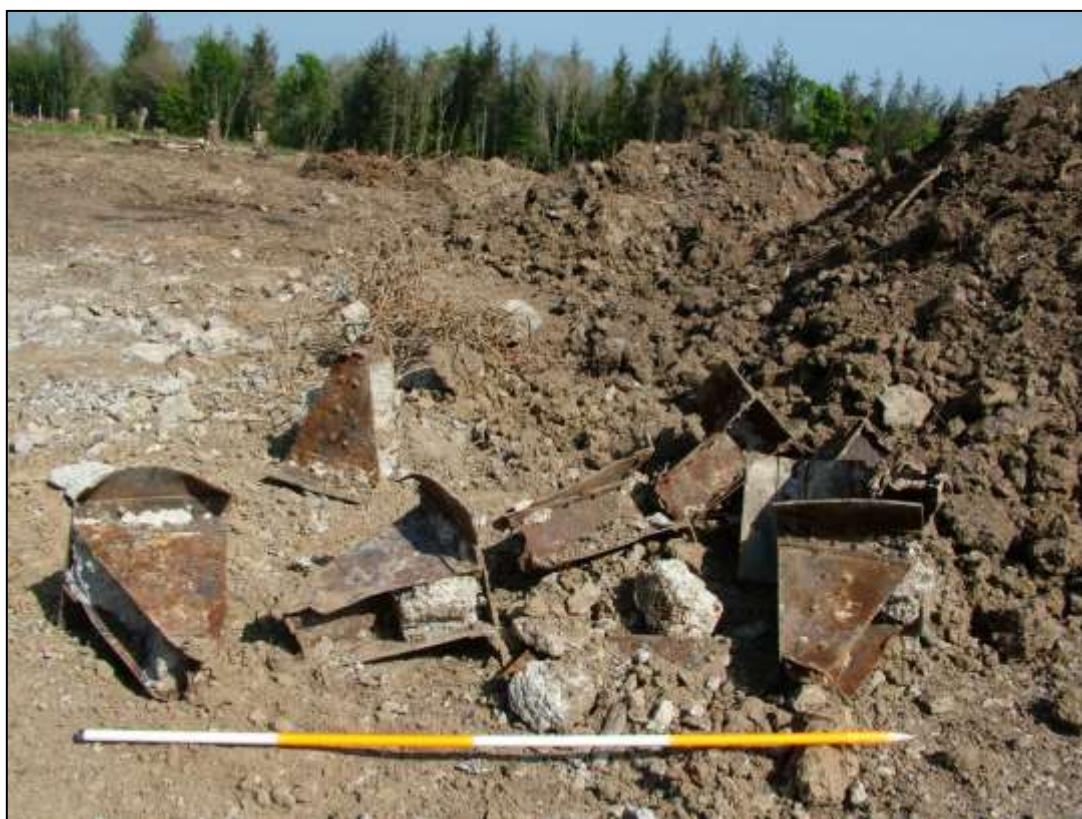
Plate 12. Area 2 – Cast iron footings from the foundations of Temporary No 4 / Block 9

Plate 12 Cast iron footing to RSJ uprights (broken out of foundations)

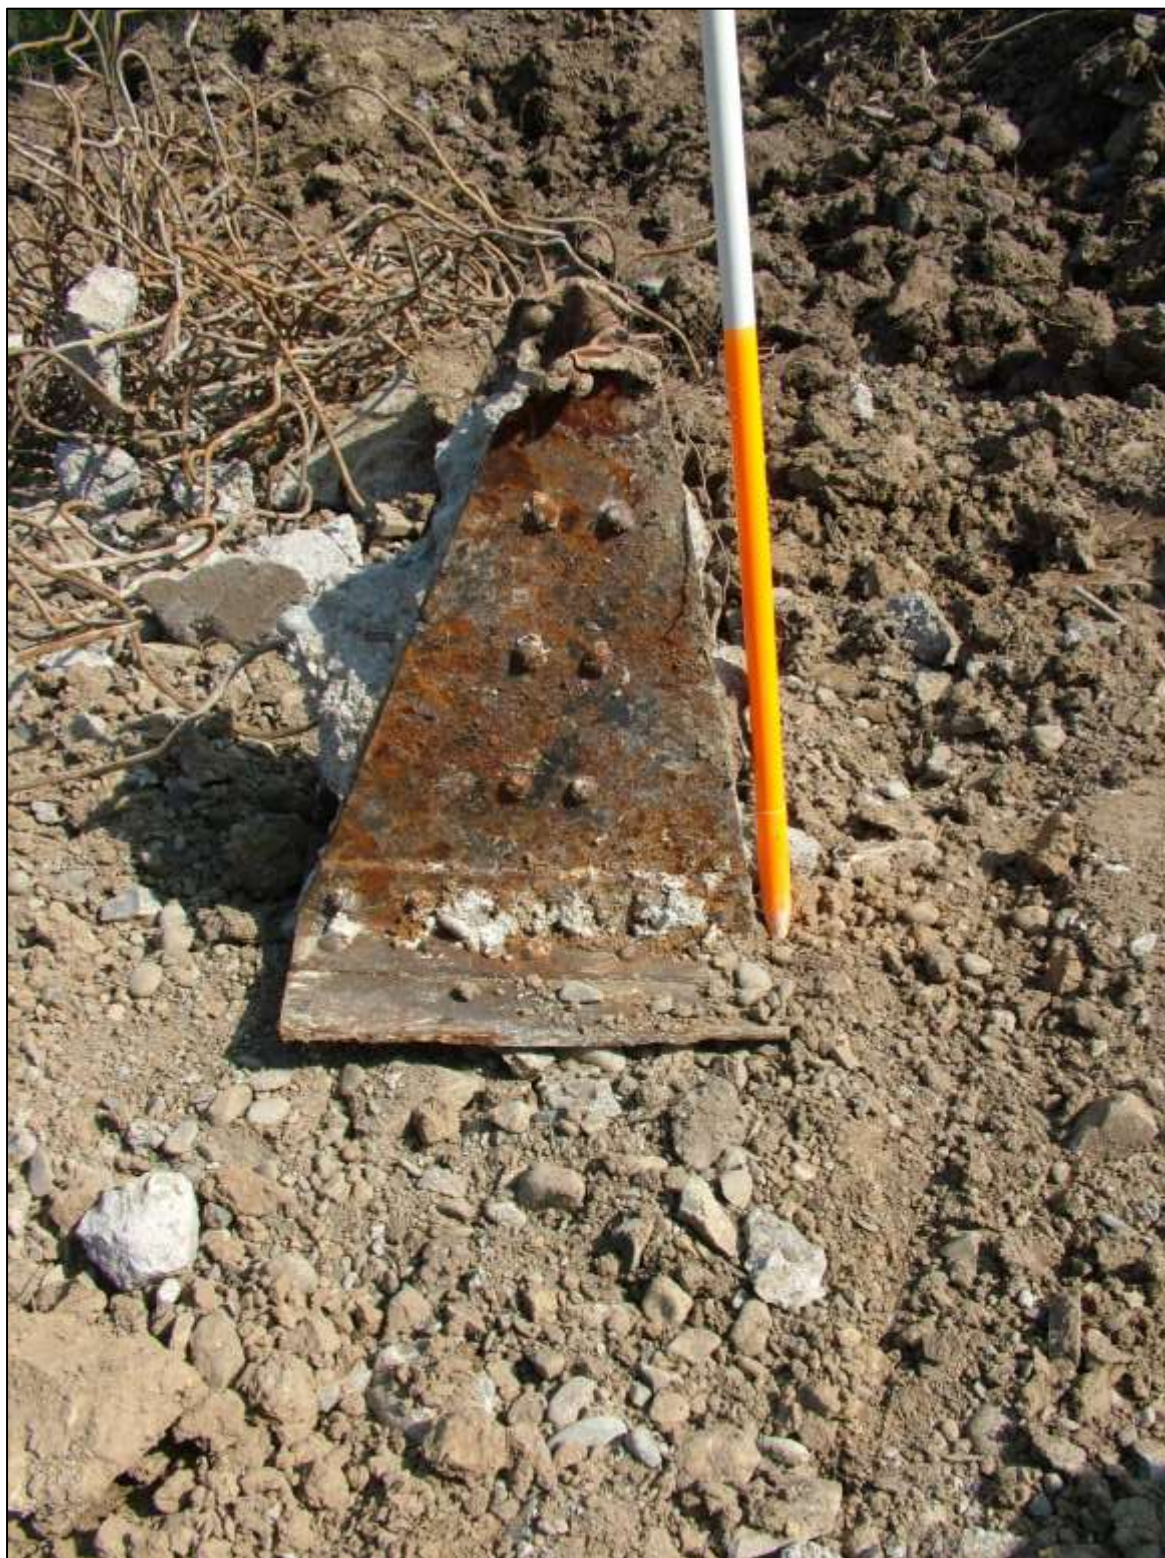
Plate 13. Detail of cast iron footing Temporary No 4 / Block 9

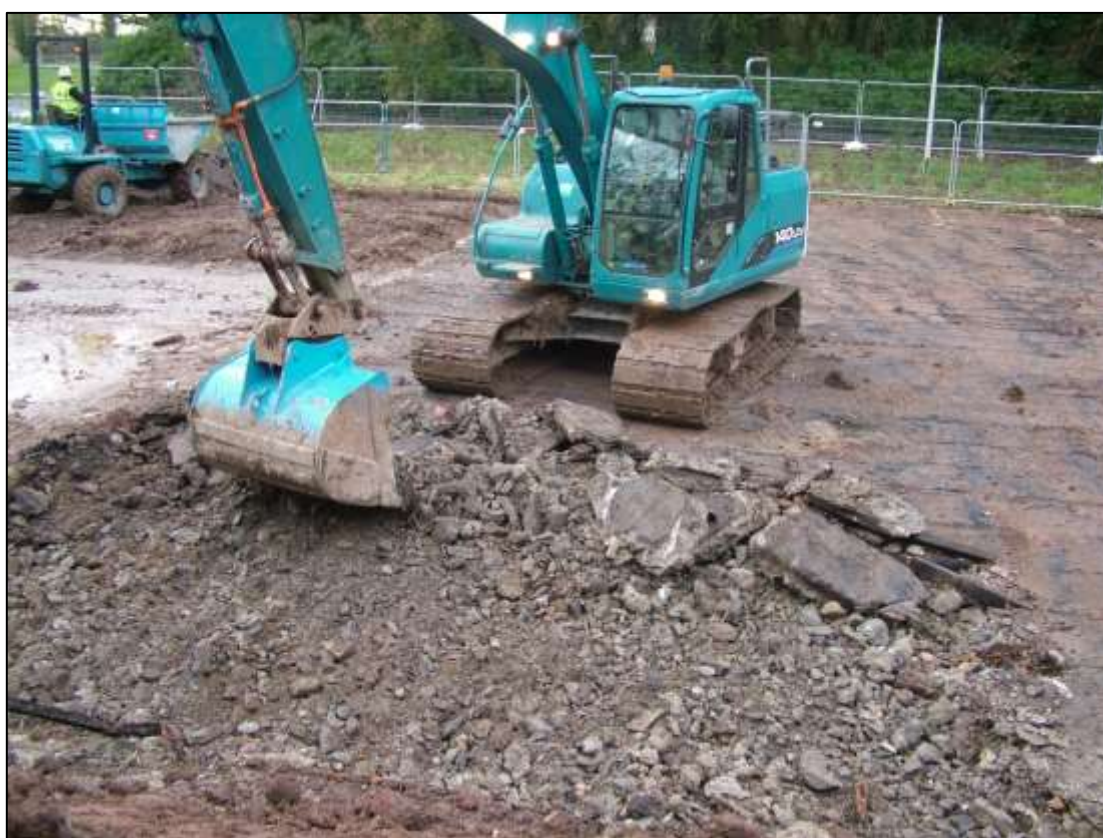
Plate 17. Area 2 – removal of asphalt subfloor, Temporary No 3 / Block 11. Looking S

Plate 17 Asphalt subfloor removal to expose foundations. Looking S

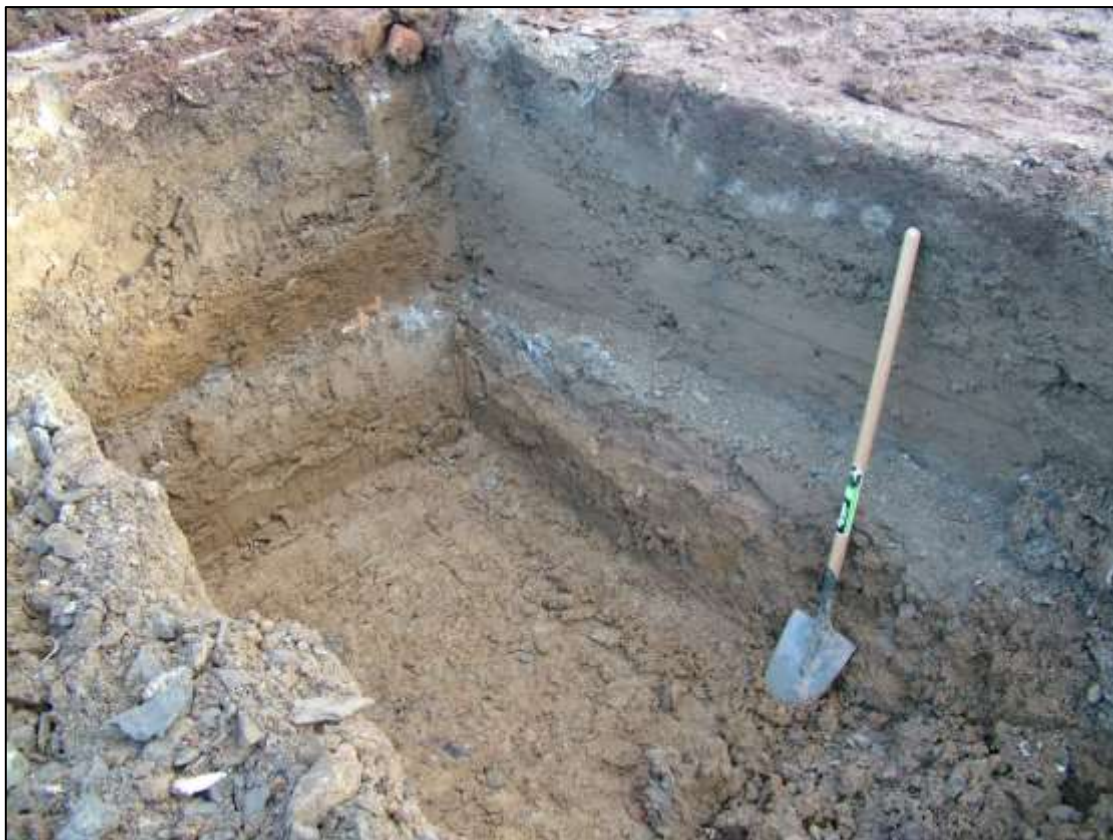
Plate 18. Area 2 – Temporary No 3 / Block 11, depth of foundation. Looking NE

Plate 18 Full vertical extent of foundation, looking NE

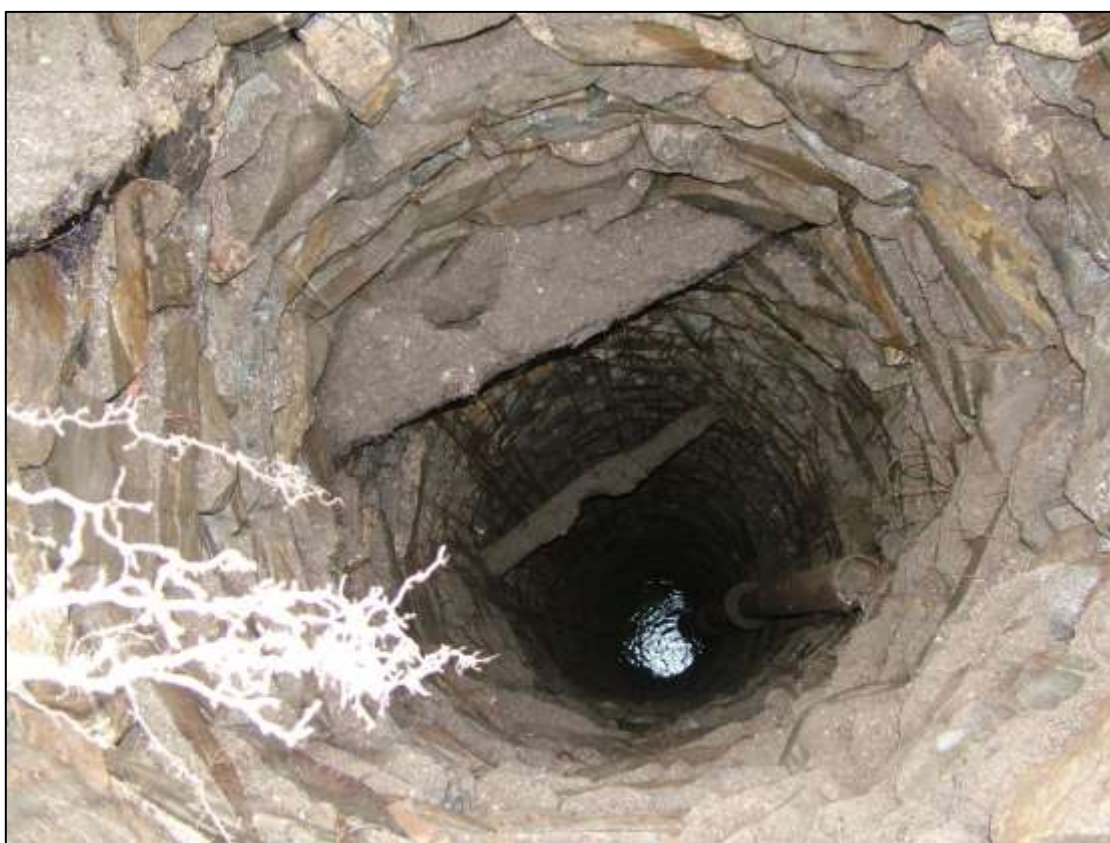
Plate 28. Area 1 – Hand dug, stone lined well 12-13m in depth

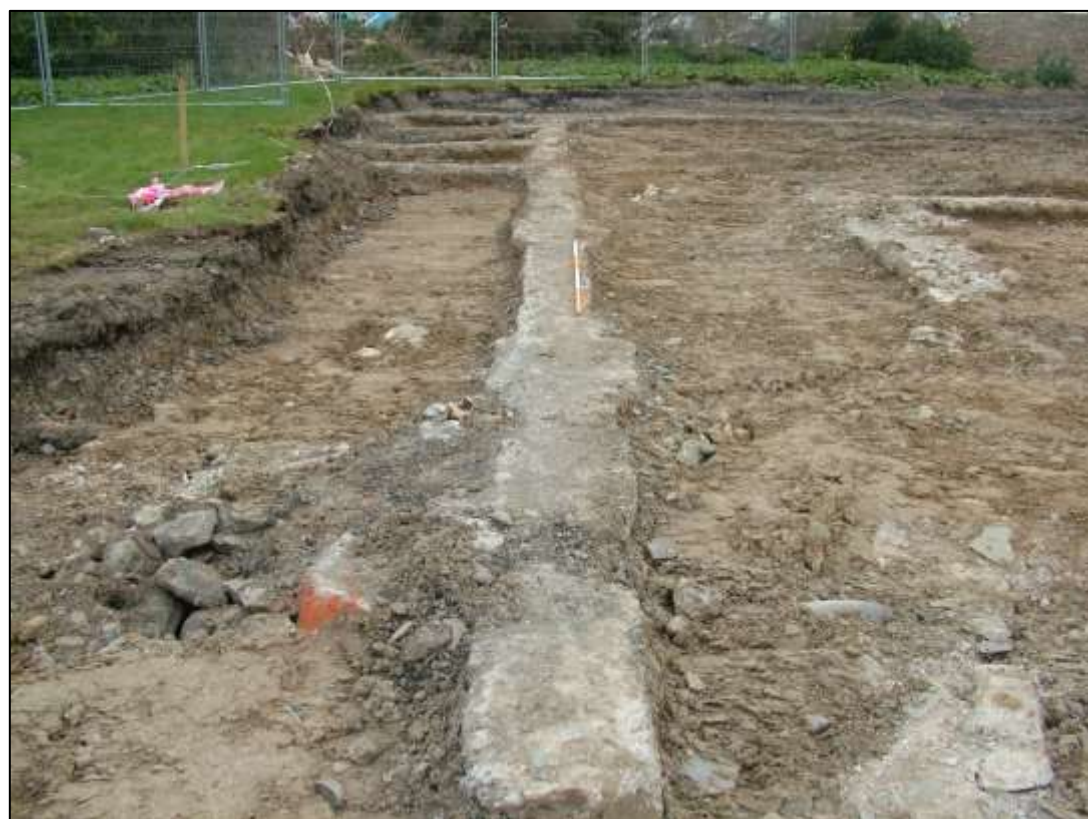
Plate 32. Area 1 – Temporary No 2 / Block 8/8a, dormitory, eastern foundation looking S to storage annex

Plate 32 Eastern dormitory block, east foundation, looking S

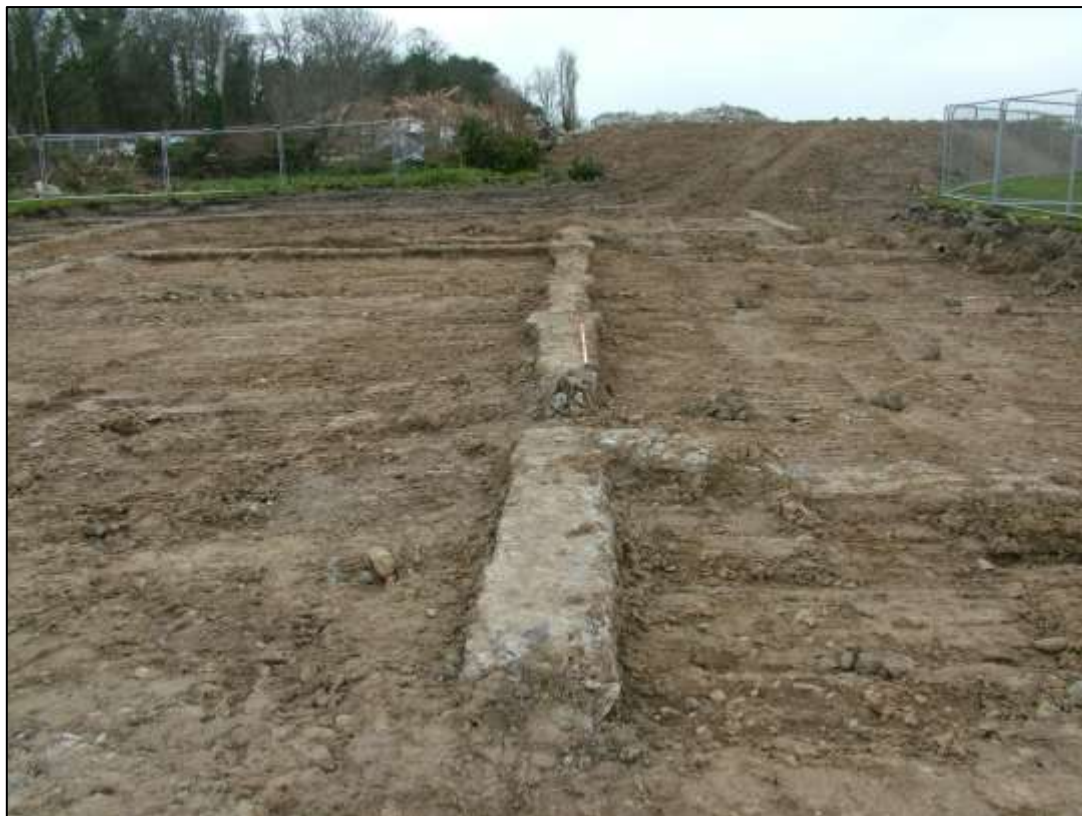
Plate 33. Area 1 – Temporary No 2 / Block 8/8a, dormitory, western foundation looking S to storage annex

Plate 33 Eastern dormitory block, west foundation, looking S

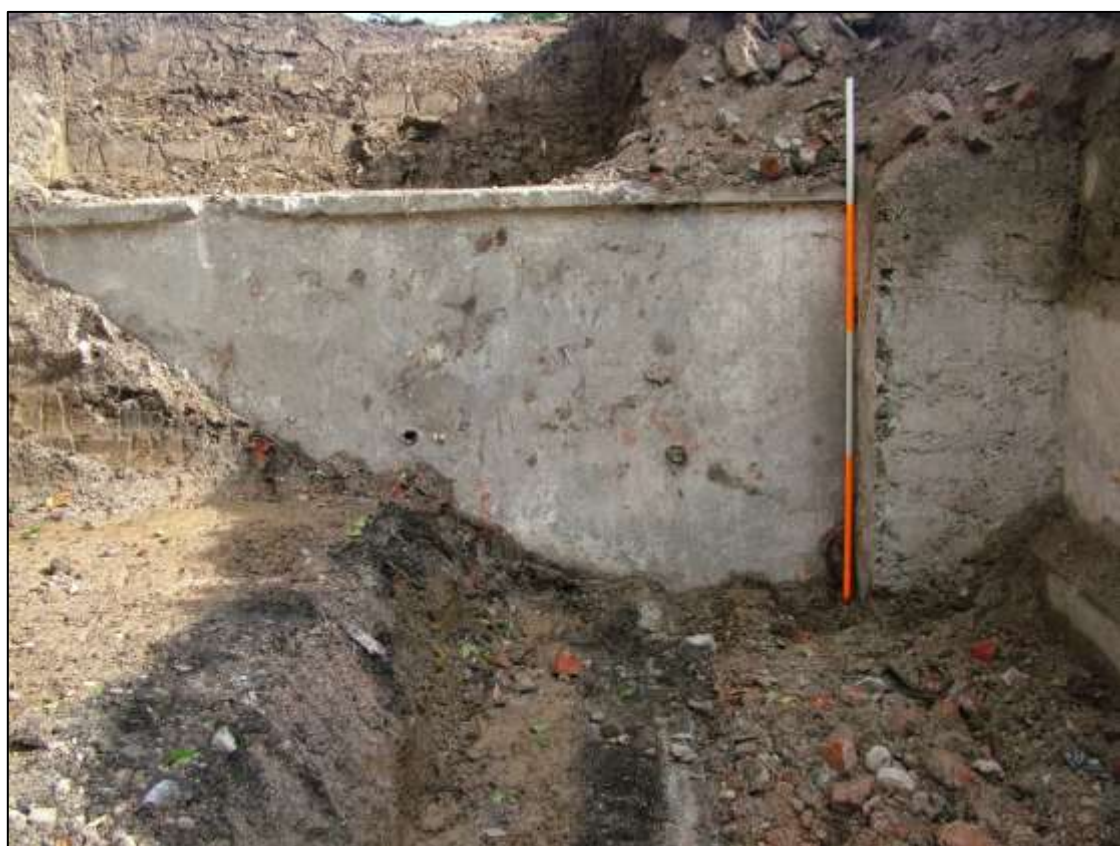
Plate 42. Area 3 – Portrane House, basement level exterior. Retaining wall, c. 1937.

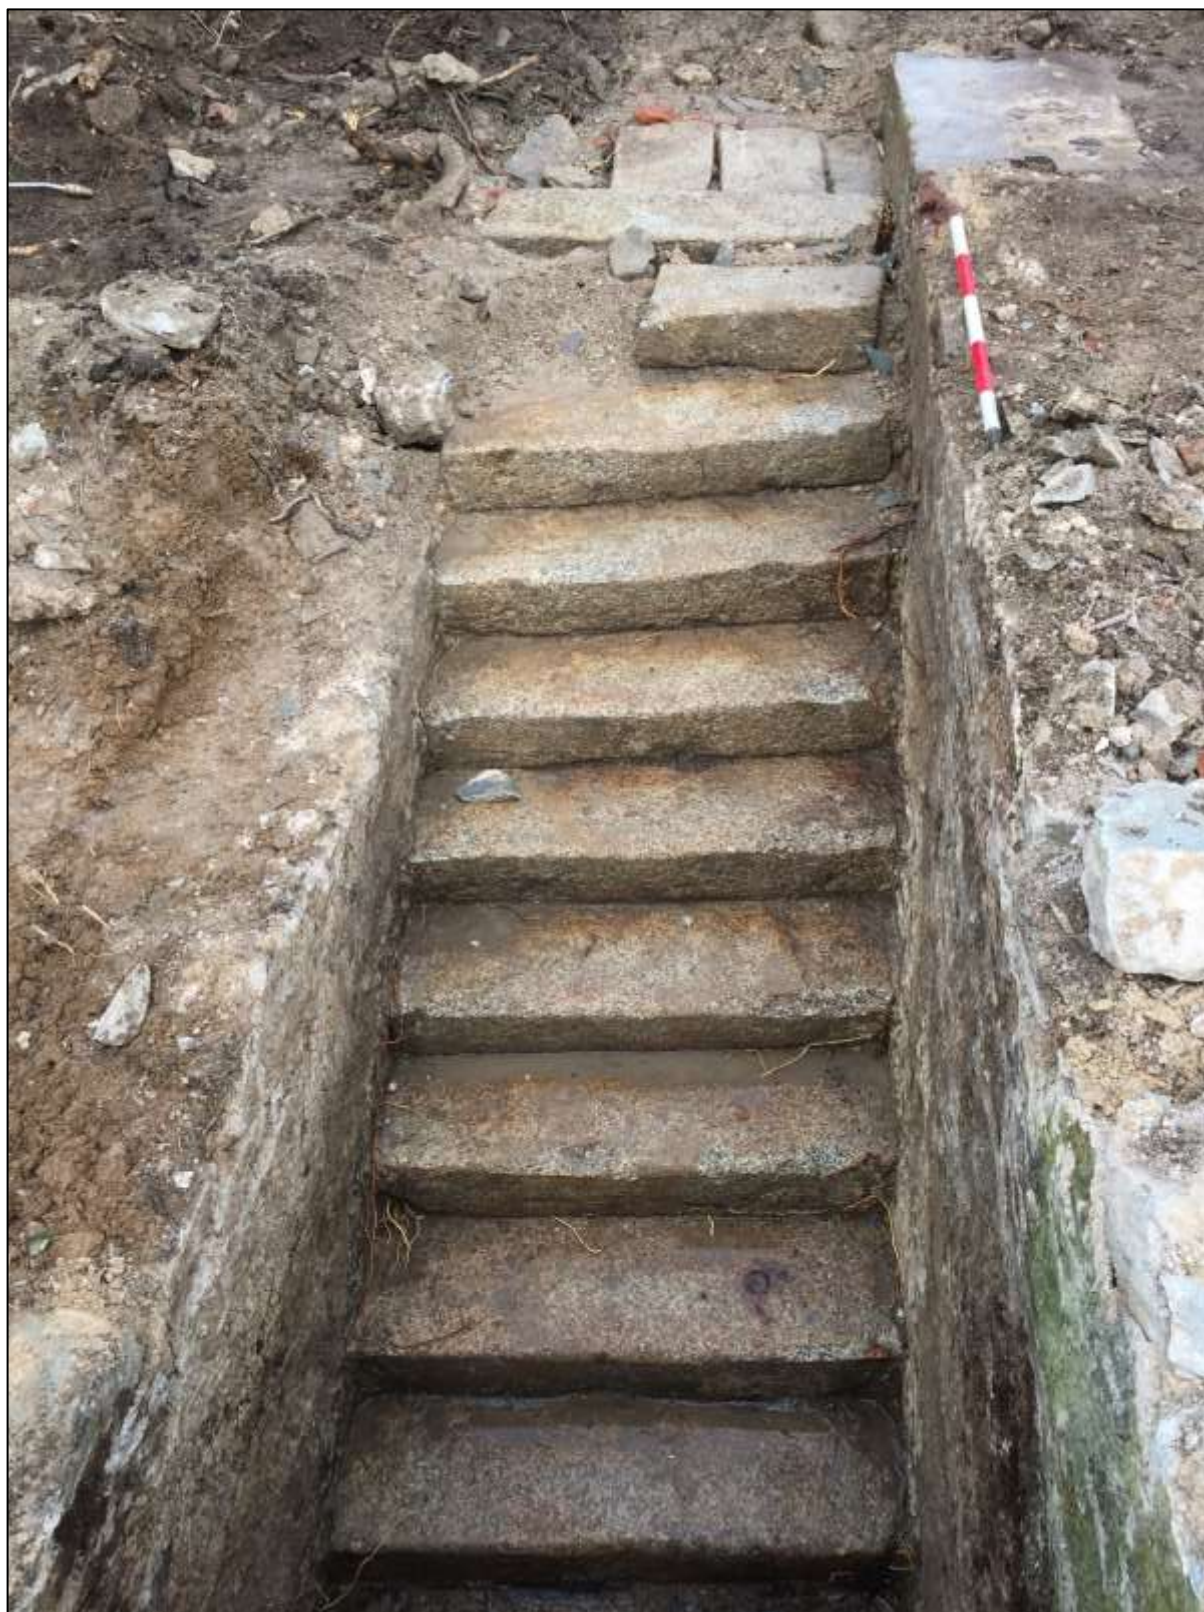
Plate 58. Staircase and stairwell to the service tunnels. Looking N

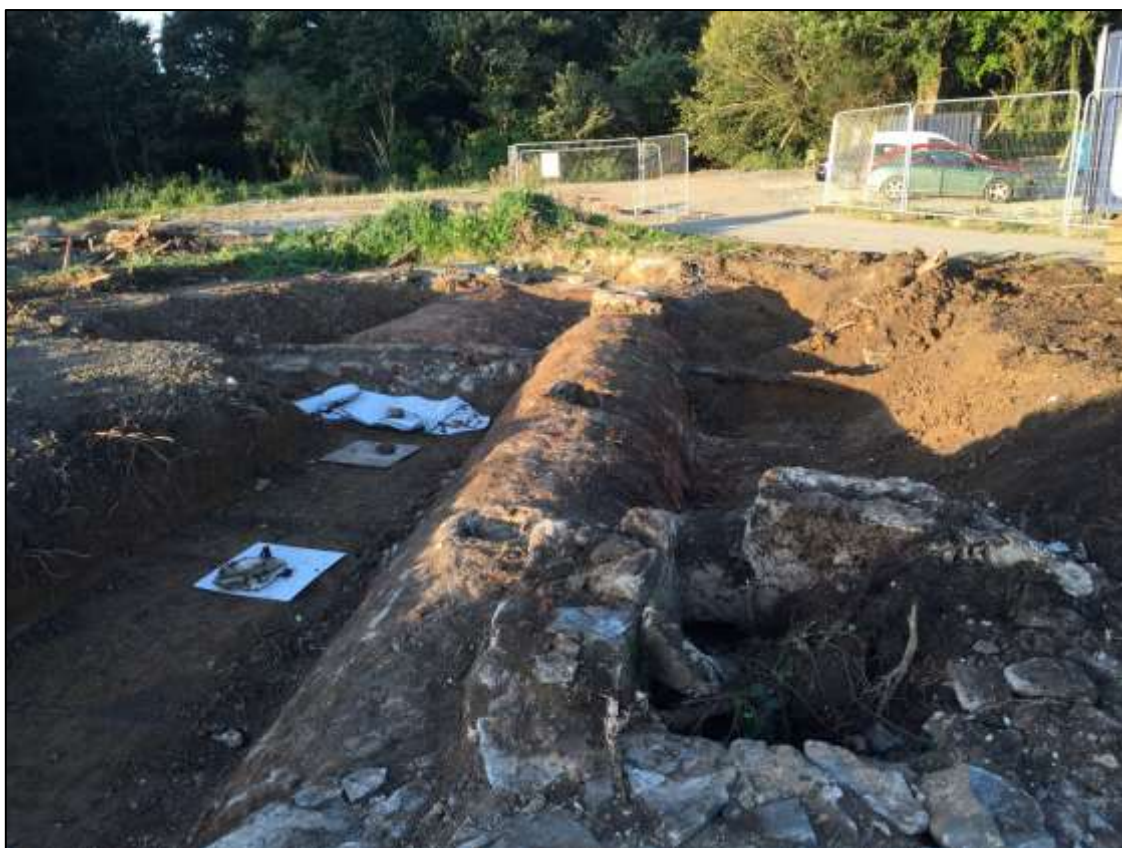
Plate 62. The service tunnel vaulted roof exposed during excavation. Looking W

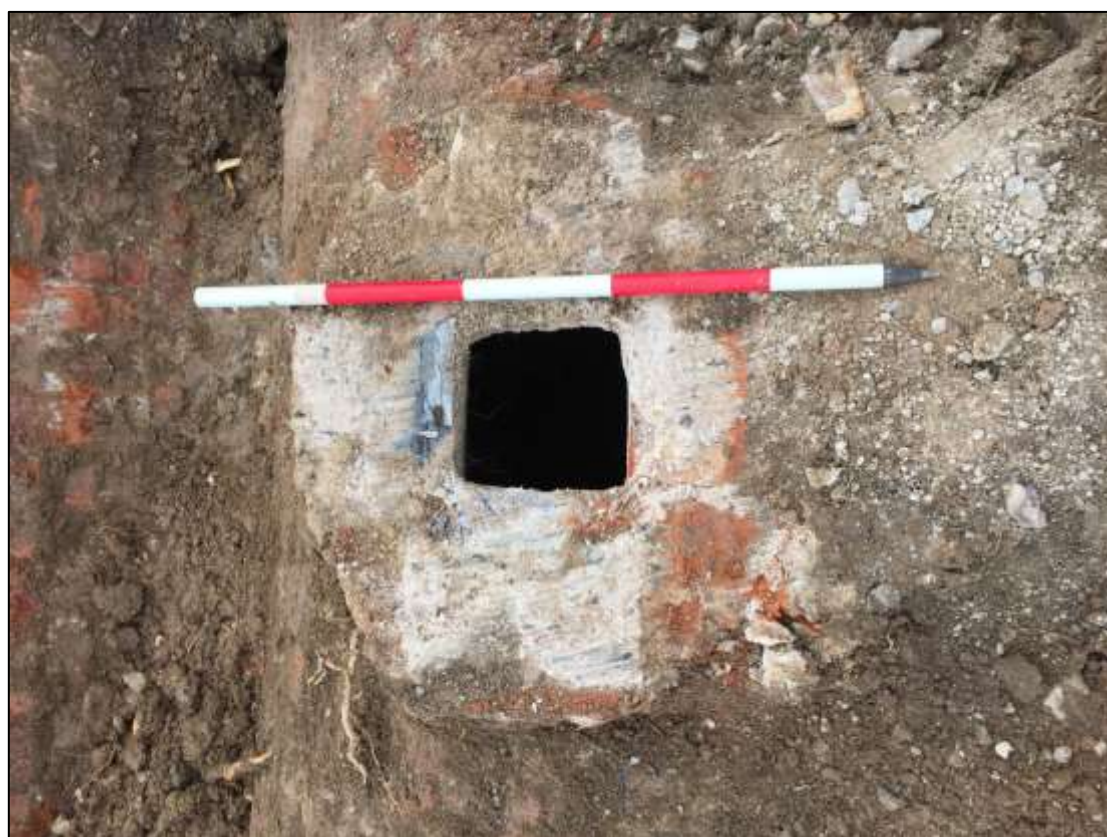
Plate 63. Skylight for illumination and ventilation of tunnels
